The R-390A Frequently Asked Questions Page

Repairing Mechanical Filters From An R-390A Graham Baxter G8OAD

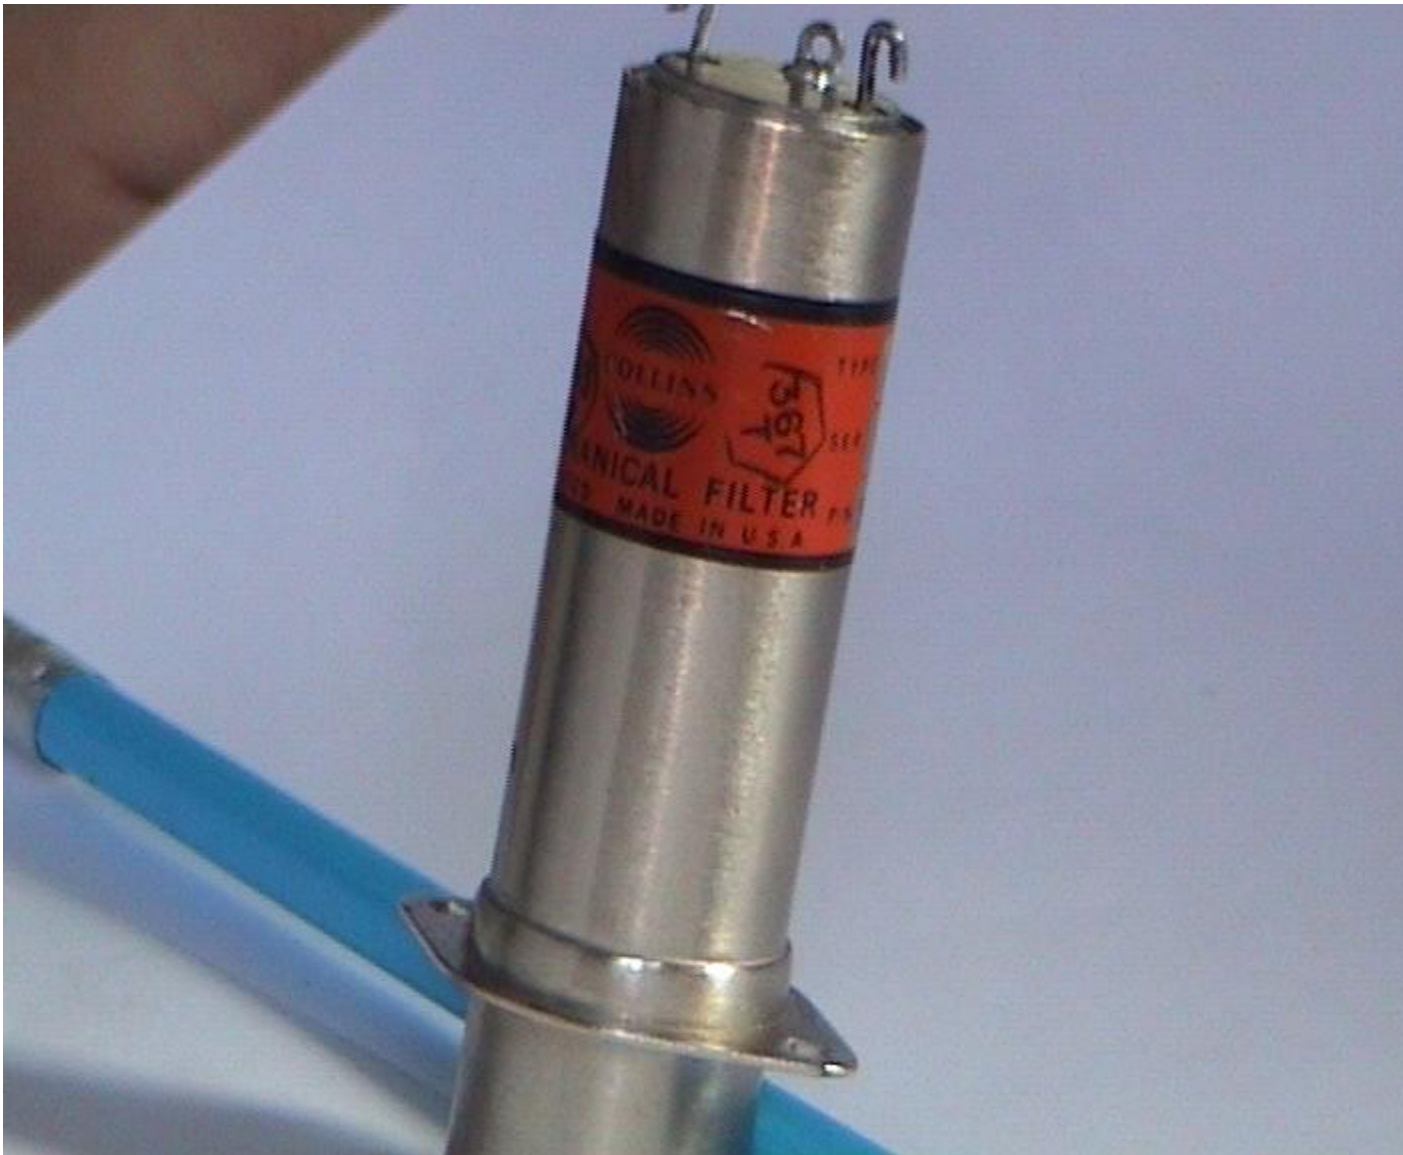
This account applies to the later style of filter where the outer barrel has a matt finish and the coil connections are diametrically opposed. The early type with a shiny barrel has a different form of construction but the principles are similar.

Many of these filters are failing. Apart from the obvious symptom where a filter winding is open circuit, they can also develop a leak to ground which spoils the operation of the AGC.

The body of the filter was originally supported within the outer barrel by a combination of stiff paper washers and foam doughnuts. Over time the foam breaks down and turns into a tarry substance which contaminates the filter. The paper becomes very brittle and crumbles.

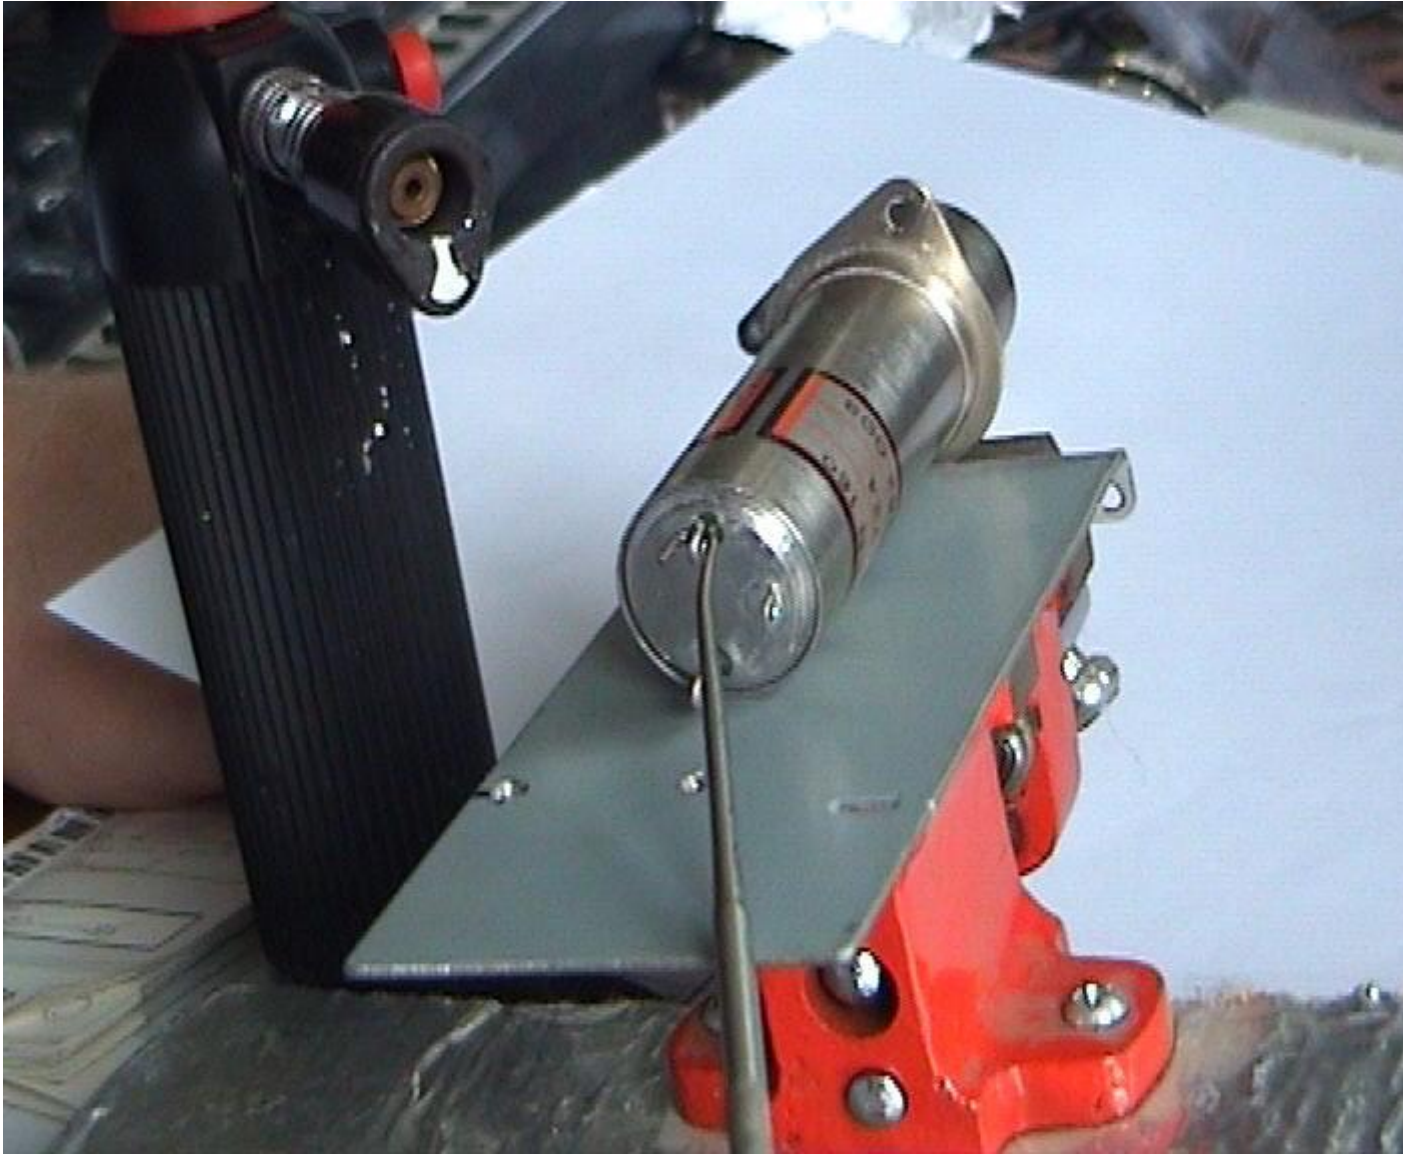
You will need a source of controllable heat. I used a small butane torch; the type used to flambe tomatos. Hold the filter horizontally by its flange in a vise. We will remove the output cap first (the one furthest from the flange). Try to arrange a metal sheet immediately beneath the filter so when the end cap comes out it has somewhere to land without pulling on the fine wires. I used a spring hook to gently pull the terminal hooks whilst playing the flame in circles around the cap. It is quite possible to do this without burning the label. Once you see the solder start to run, carefully put down the butane torch (something else I didn't do first time round) and then gently pull the cap. It should slide out with little resistance. Let it rest on the tray to cool.

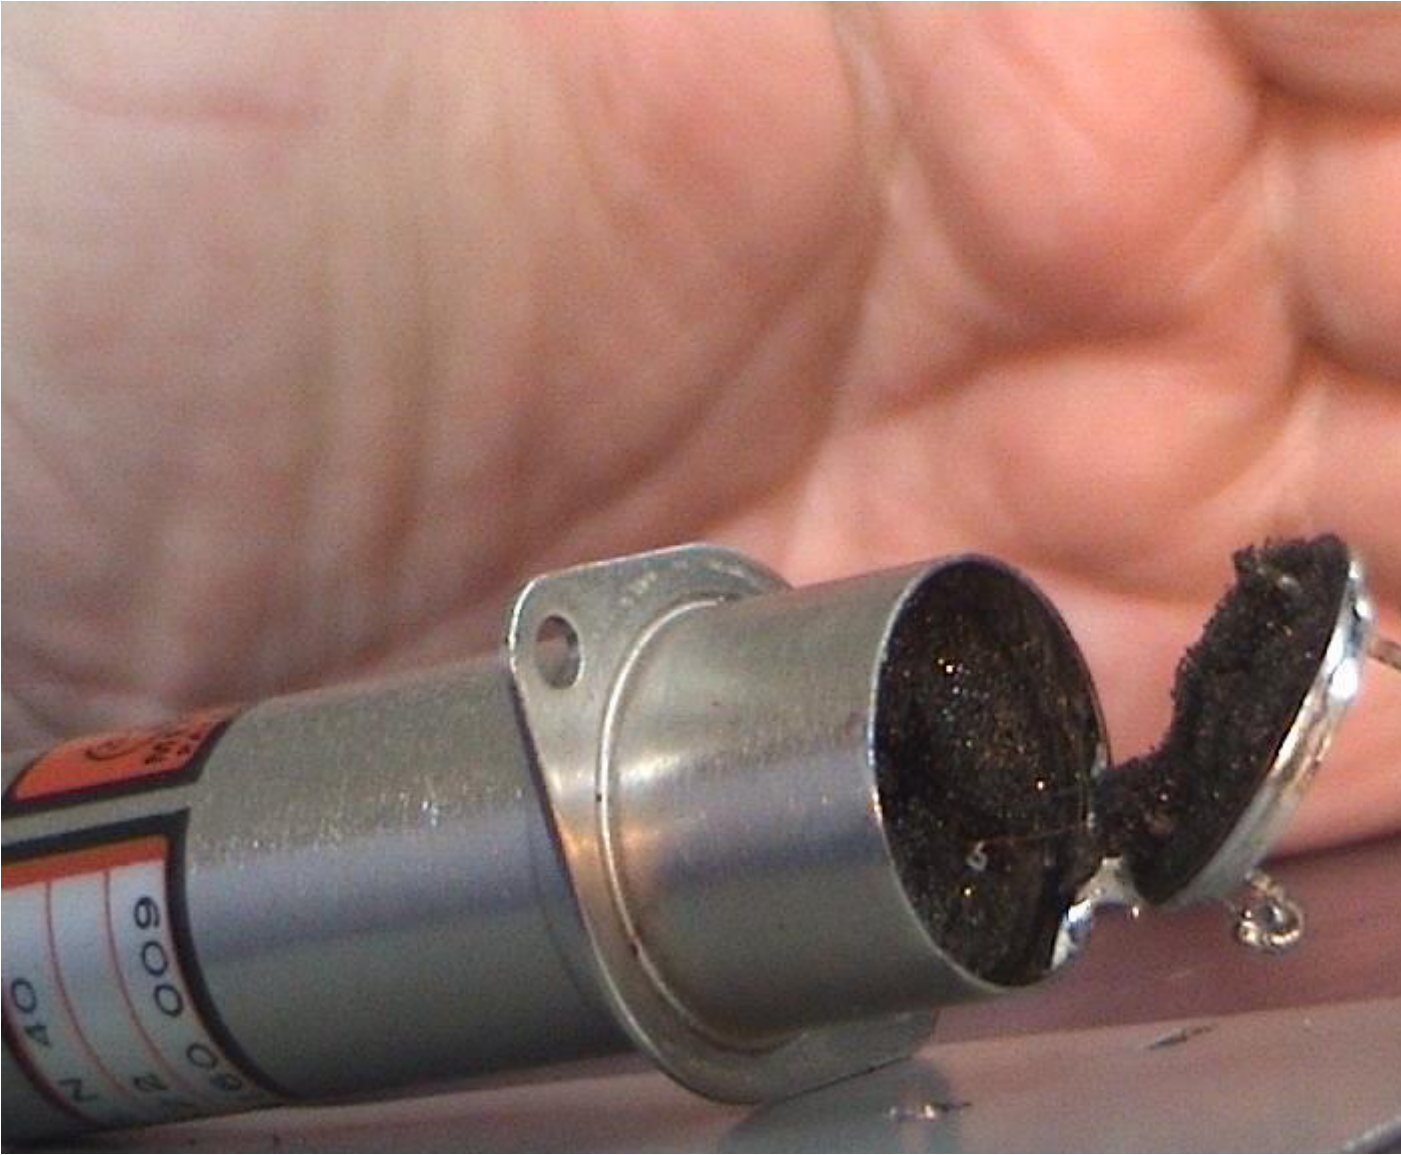
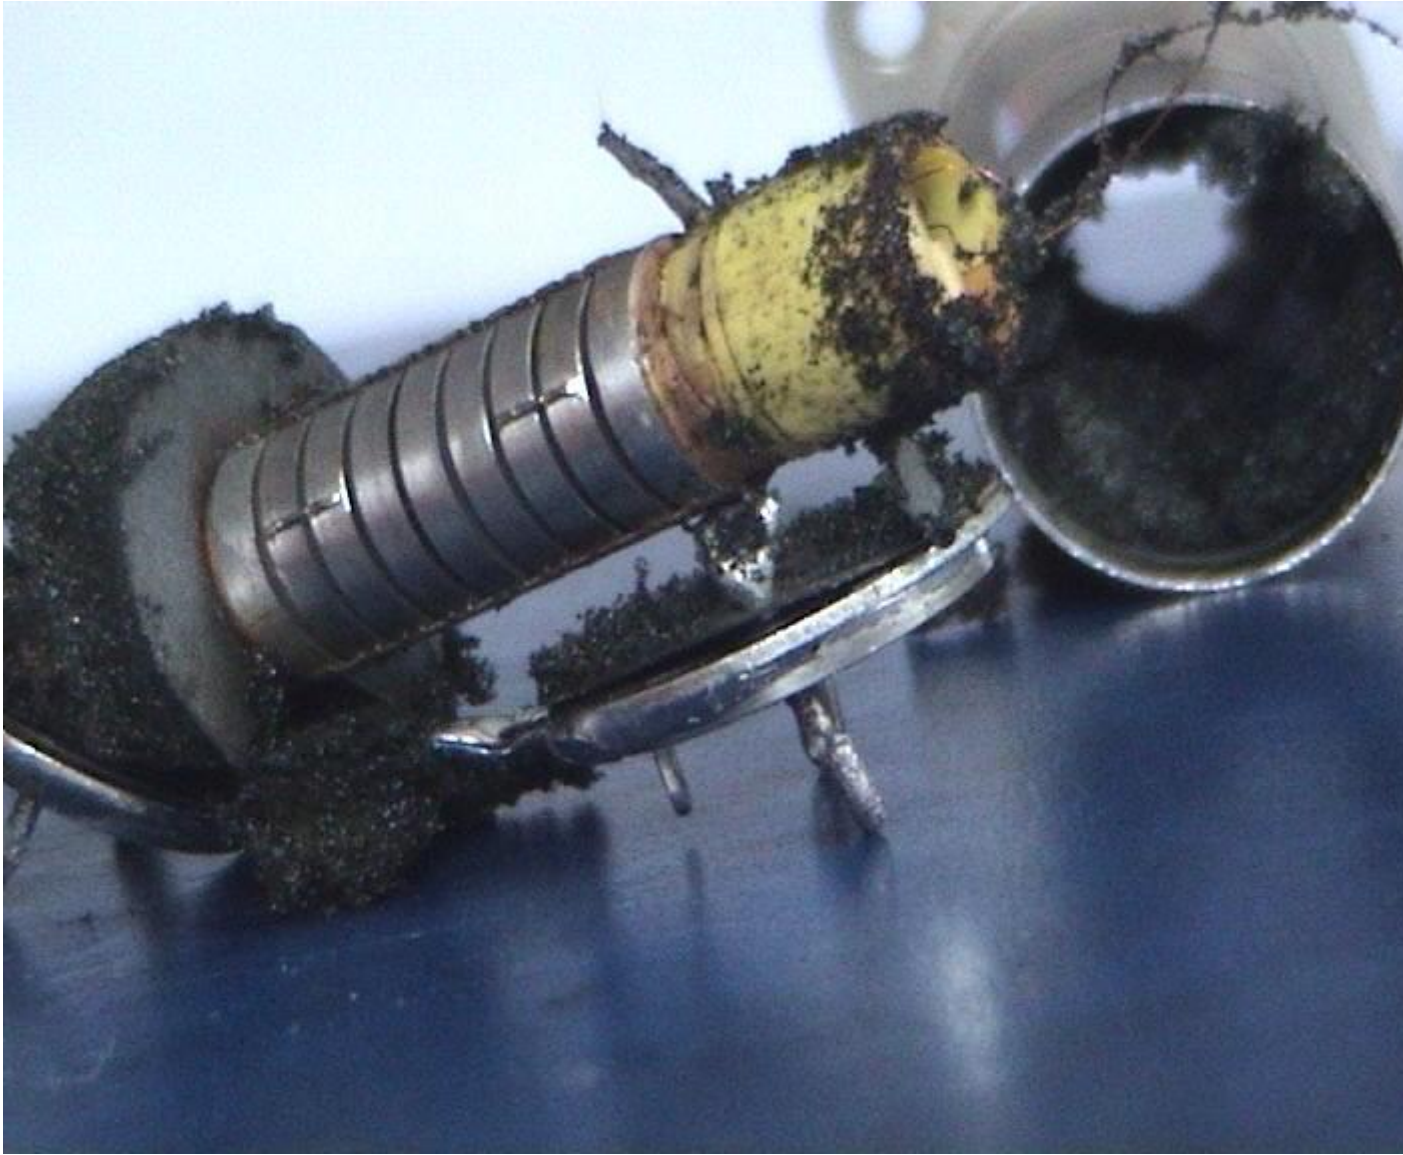
When it is cool enough, snip the two fine wires from the solder tags on the end cap and place the cap out of the way. Turn the filter round in the vise and remove the second cap. This one may be slightly tighter since it should have the earth wire trapped between its periphery and the barrel. Disconnect the wires as before.

Remove the paper insulators from the end caps and examine the caps with an eye-glass. The ones I have examined have had a build-up of conductive detritus around the terminal insulators.

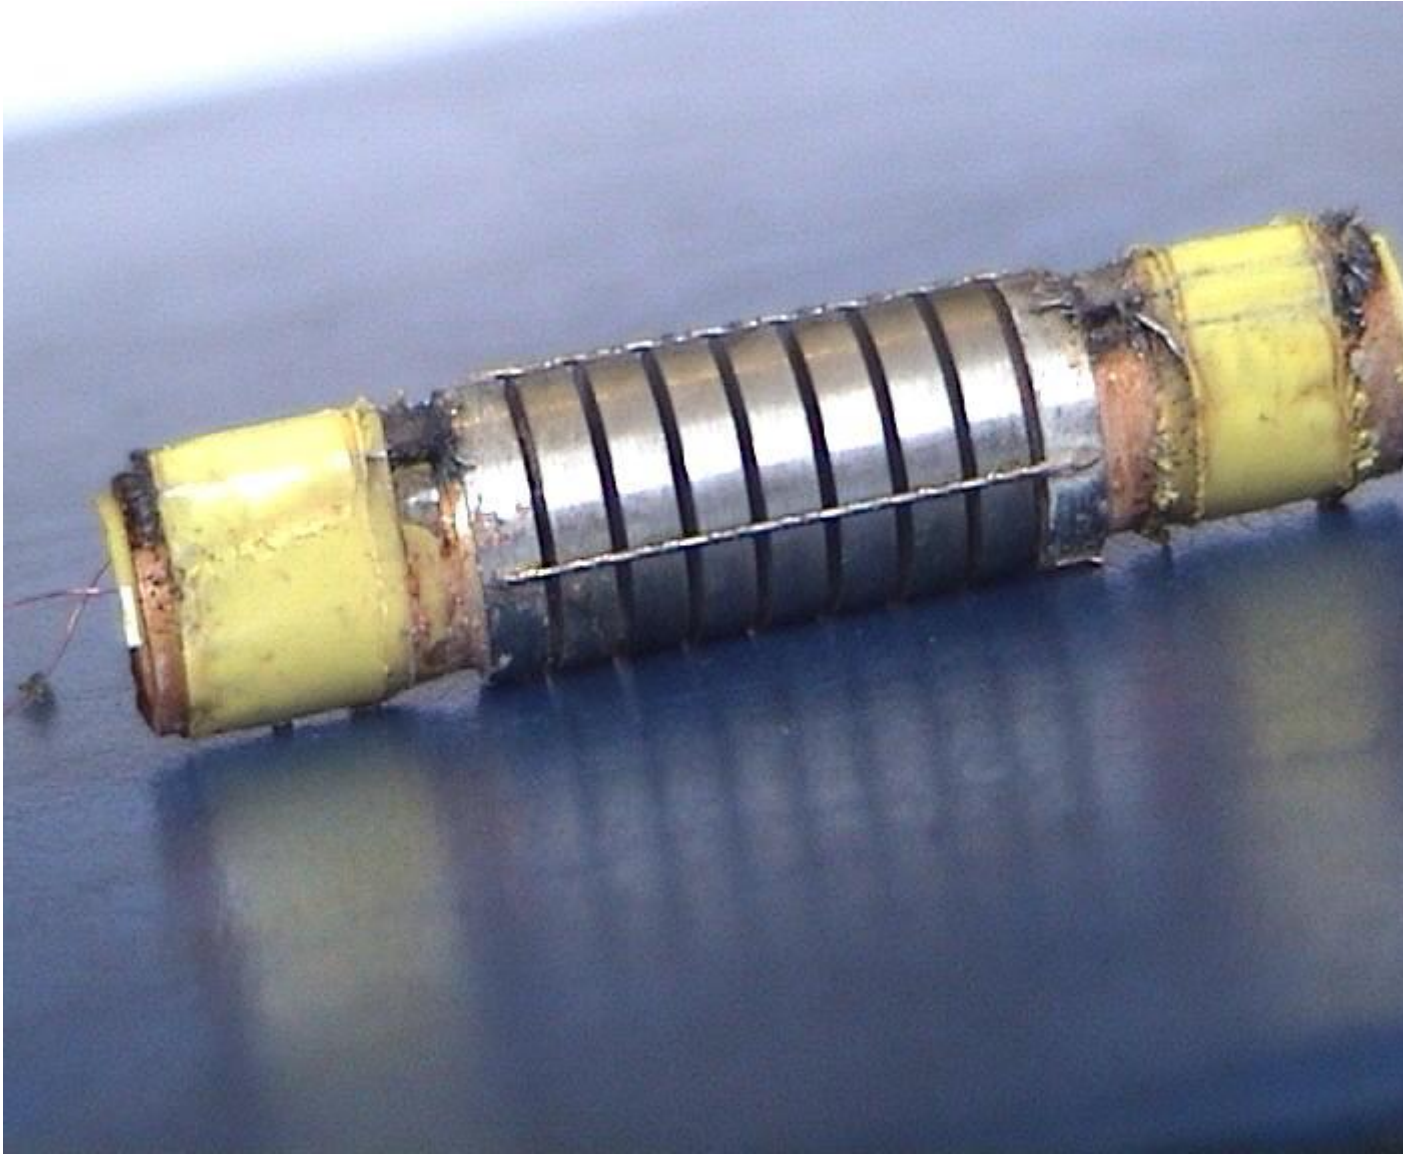
By now the filter will have cooled. You will probably see a dismal black powdery sticky goo. This used to be foam rubber. It is amazing that a substance can be both powdery and sticky. Keep it off your clothes. I scooped most of it out with a spring hook. Carefully withdraw the mechanical assembly.

You will see that the filter comprises a set of disks with a coil at each end. This assembly will almost certainly need to be cleaned. In my case the debris from the foam had gone between the disks. Fortunately it seems to clean off quite well in alcohol. Be careful not to bend any of the coupling rods whilst handling the assembly.

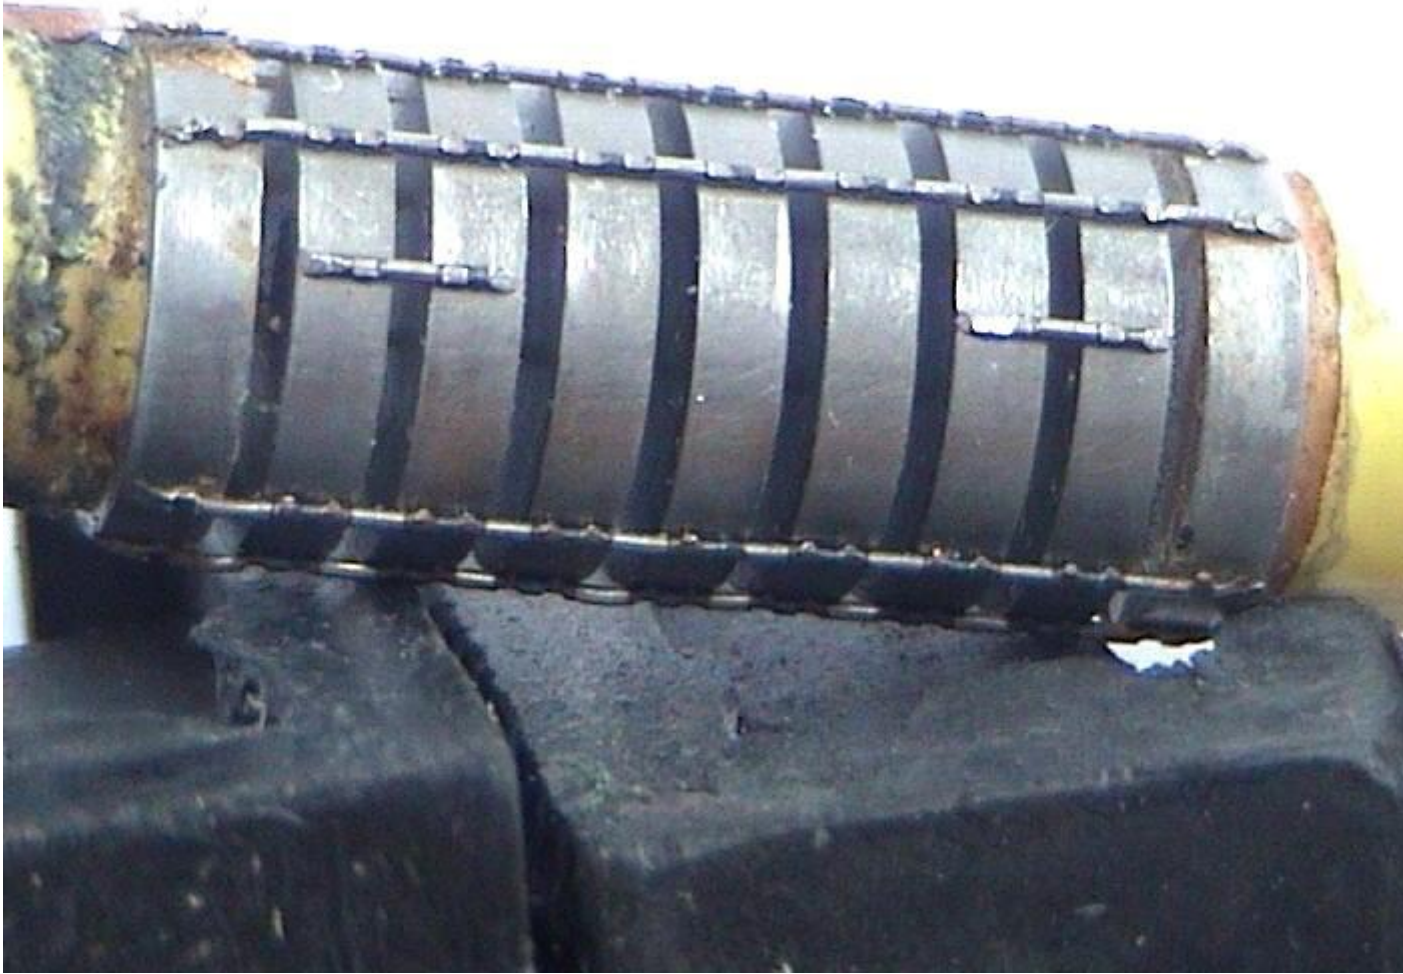
At each end of the filter, there is an actuator coil which sits inside a copper cup. In the centre of the coil there is a very fine magnetostrictive needle. On the outside of the copper cup there is a bias magnet which is both glued and taped in position. I removed the tape and the magnets in order to get the assembly clean.

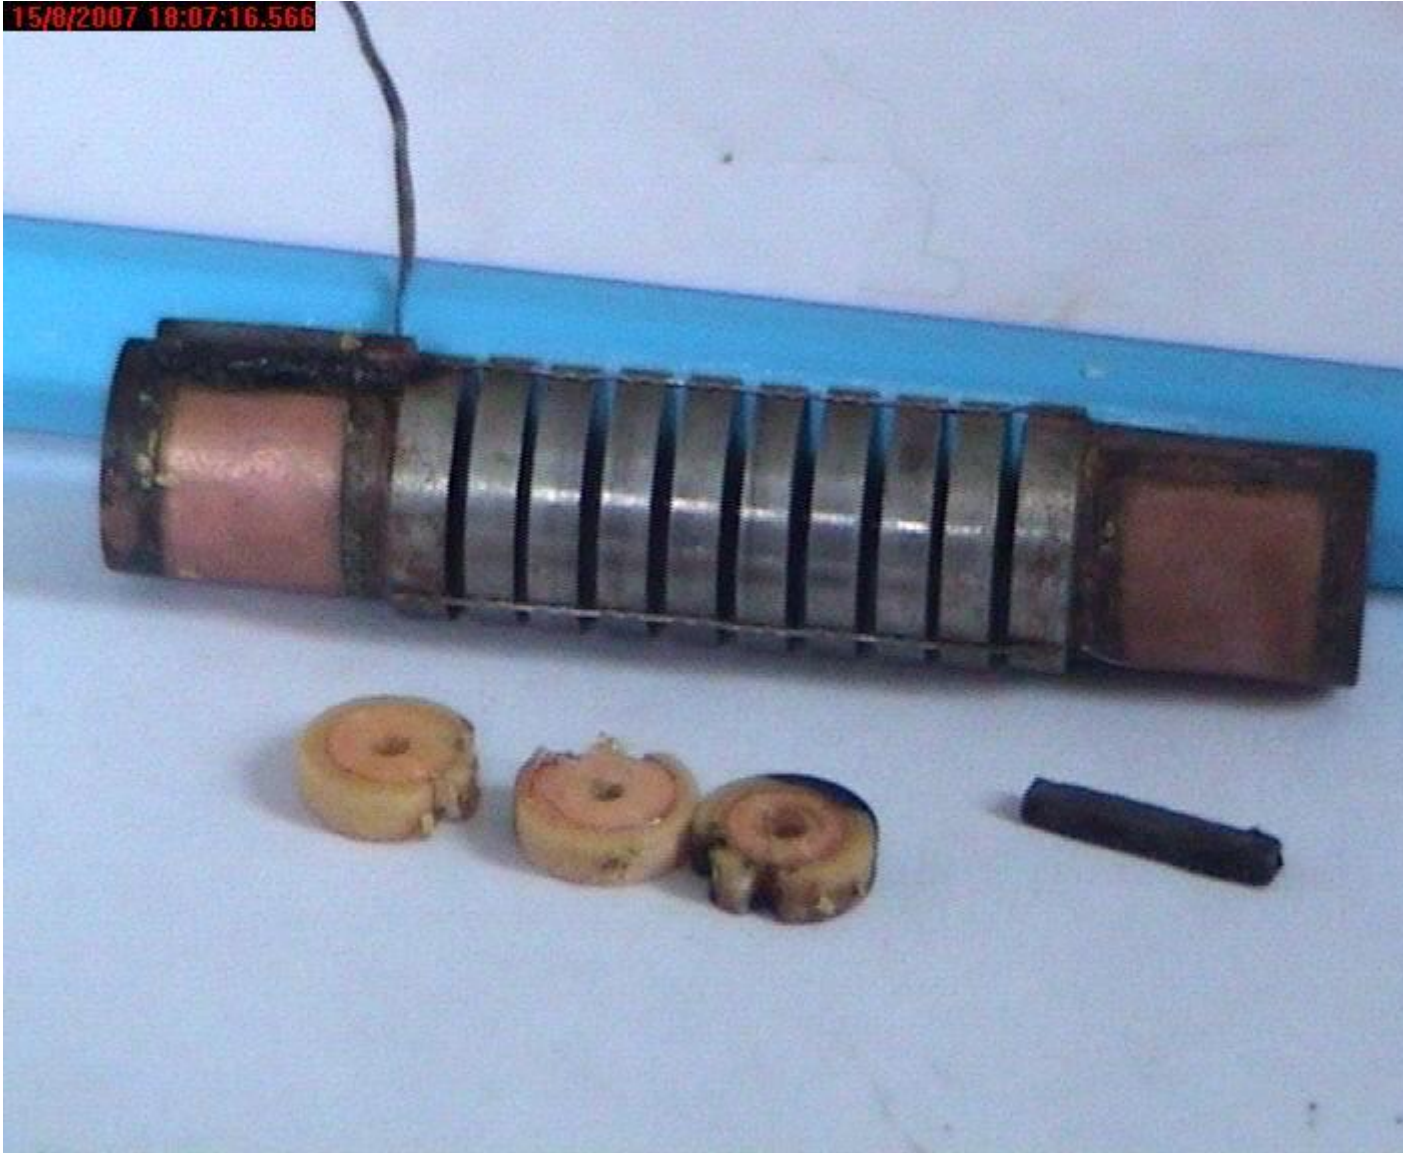
In the foreground of this picture are the three cheek pieces which form part of the coil. More about them later.

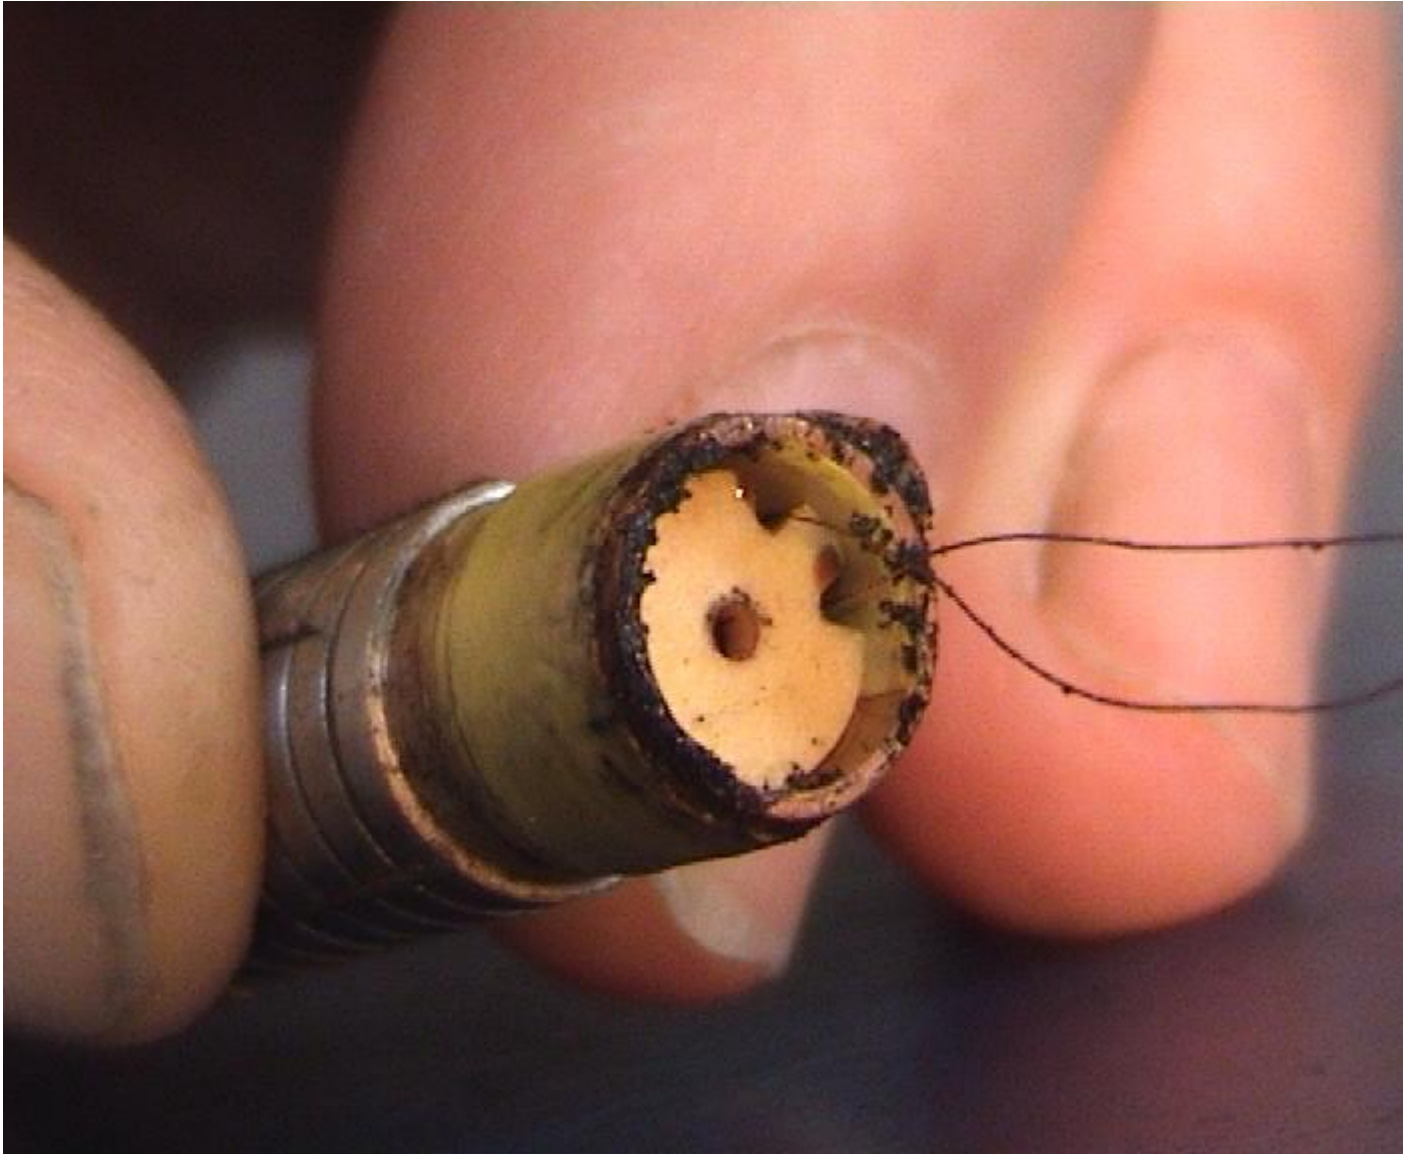
Here is a picture of the coil in position. You will also see the bias magnet held to the outside of the copper cup with yellow tape. Note also the helpful tape for withdrawing the coil.

You can just make out the actuator wire in the centre of the coil. Here is a picture of the cup and the actuator wire with the coil removed. You can also see my replacement copper tape earth wire, which I soldered on top of the broken stub of the old one.

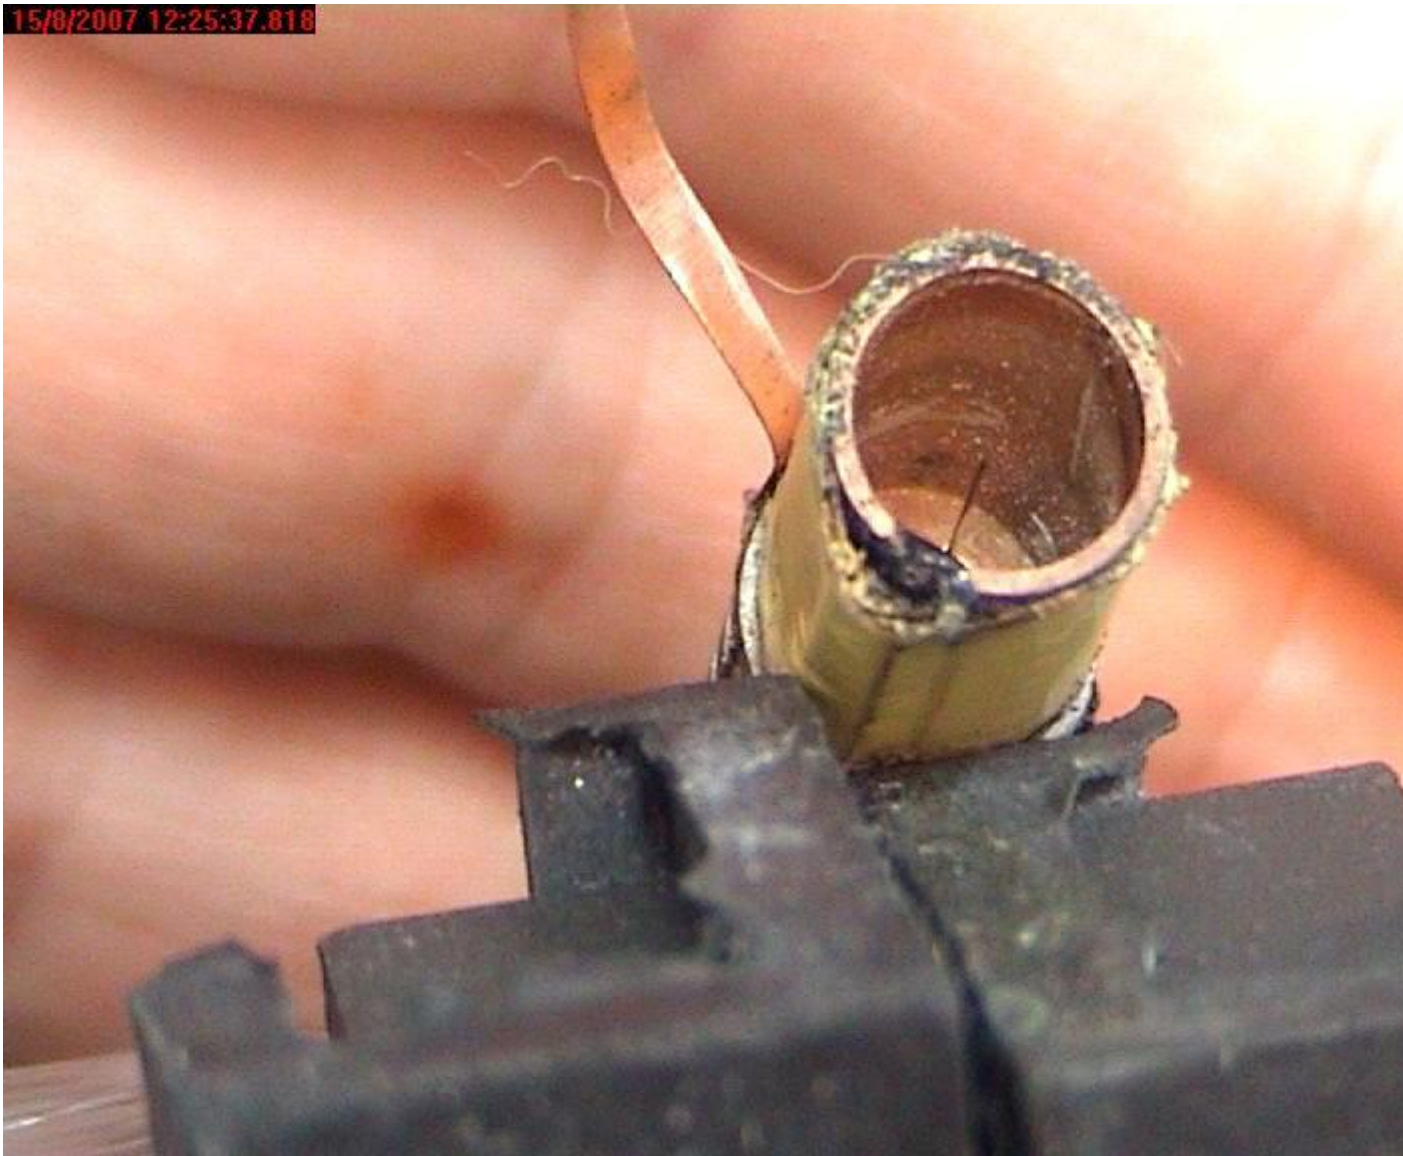
This gives an idea of the delicate nature of the wire. Note for purposes of scale one of my dog's hairs is stuck to the tape! Although you should not bend this wire, if you accidentally do so it can be gently manipulated with hairspring tweezers to get it centred. Use a pulling action rather than a kinking one.

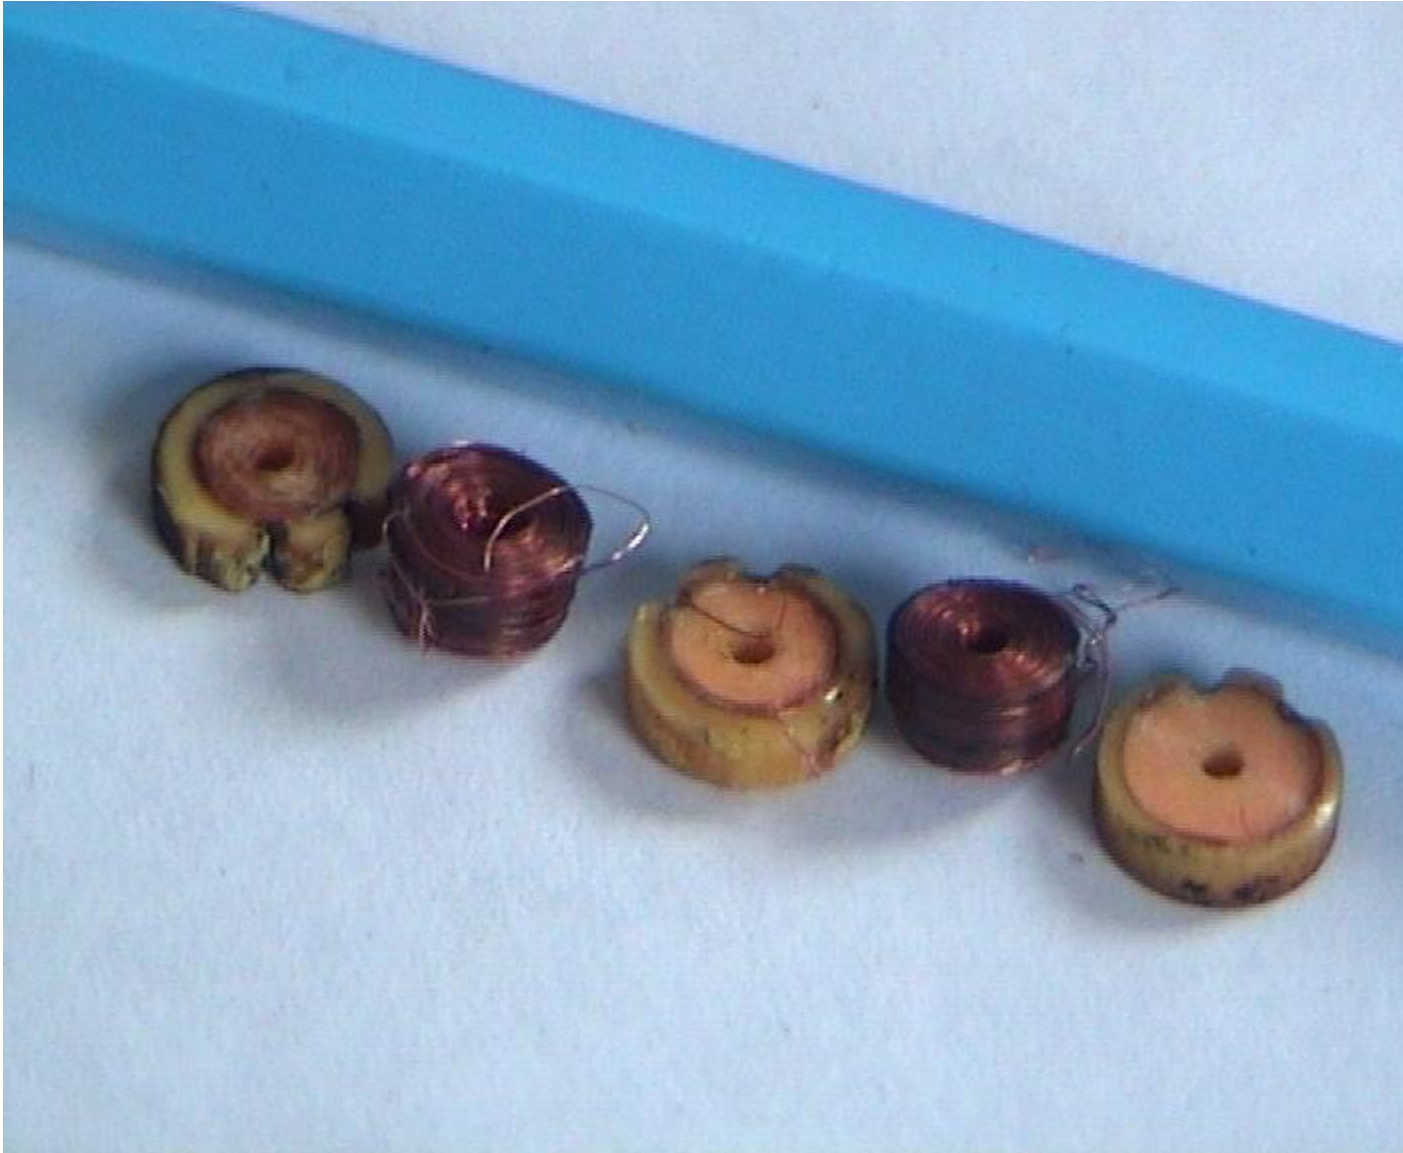
There are two causes of electrical leakage. I had both in the same filter. One is a build-up of conductive rubbish on the glass feedthrough insulators. Needless to say these need to be cleaned until they glisten. The other is more serious and it appears to be a conductive film between the coil winding and the copper cup. This is presumably a combination of a breakdown of the wire enamel and a contamination of the cheeks. This necessitates rewinding the coil. Since one of mine was open circuit I was already resigned to doing that.

The coil is wound in two sections using three insulating washers, two as cheeks and one as the central partition. There is no coil former; the coil is self supporting. You may want to count the turns on your coil to see if you get the same answer as me. I think there are 610 turns of 0.071 mm (0.003") enamelled copper wire per section. The real interesting thing is that the phase of the coil reverses at the centre. So you wind 610 turns, cross the centre partition and then wind 610 in the opposite direction.

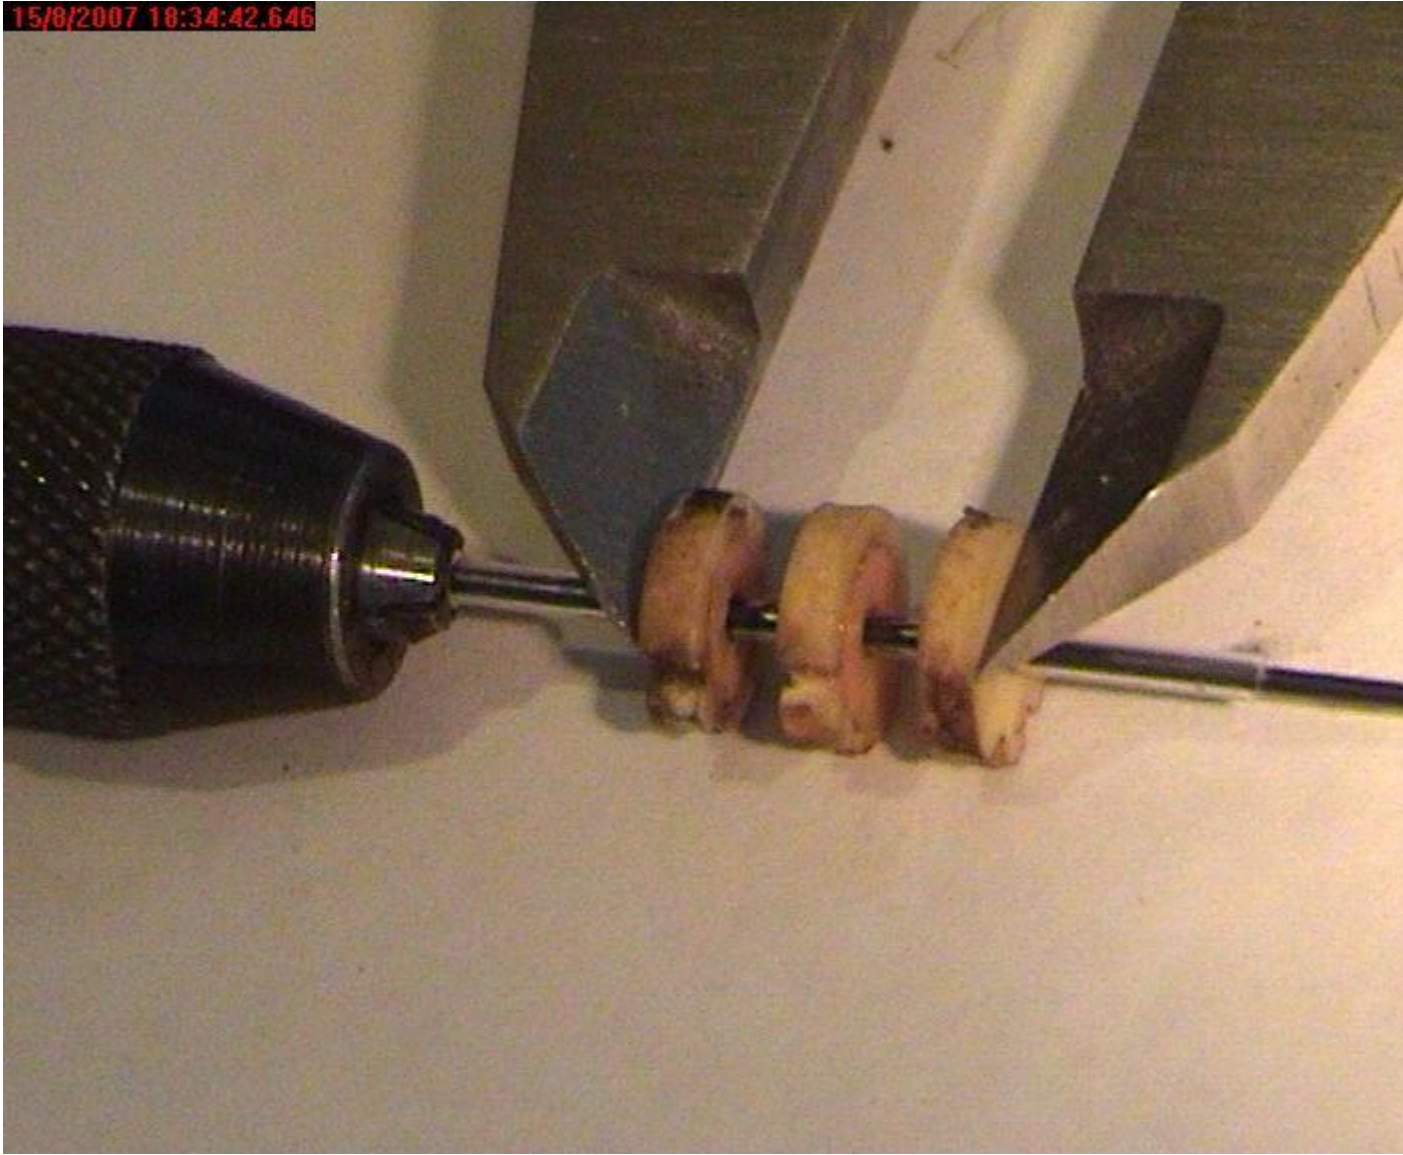
Here you see the three cheek pieces threaded onto the PTFE sleeving. There is a length of blue pivot steel inserted into the sleeving. The pin-vice is gripping the sleeving in order to drive it. Note that the outside distance of the outer cheeks should be about 9.8mm. It is best to err slightly on the tight side since they tend to spread a little when the wire is applied. The centre cheek is centrally disposed between them.

In order to wind a formerless coil, you need to wind it on a mandrel which will be withdrawn when the coil is finished. But this is a tiny job. My first efforts failed because the mandrel damaged the wire as I withdrew it. My friend Mick Bignell, who is famous for thinking out of the box, came up with the answer. Use a piece of PTFE sleeving as the mandrel, but stiffen it with a steel rod up the centre.

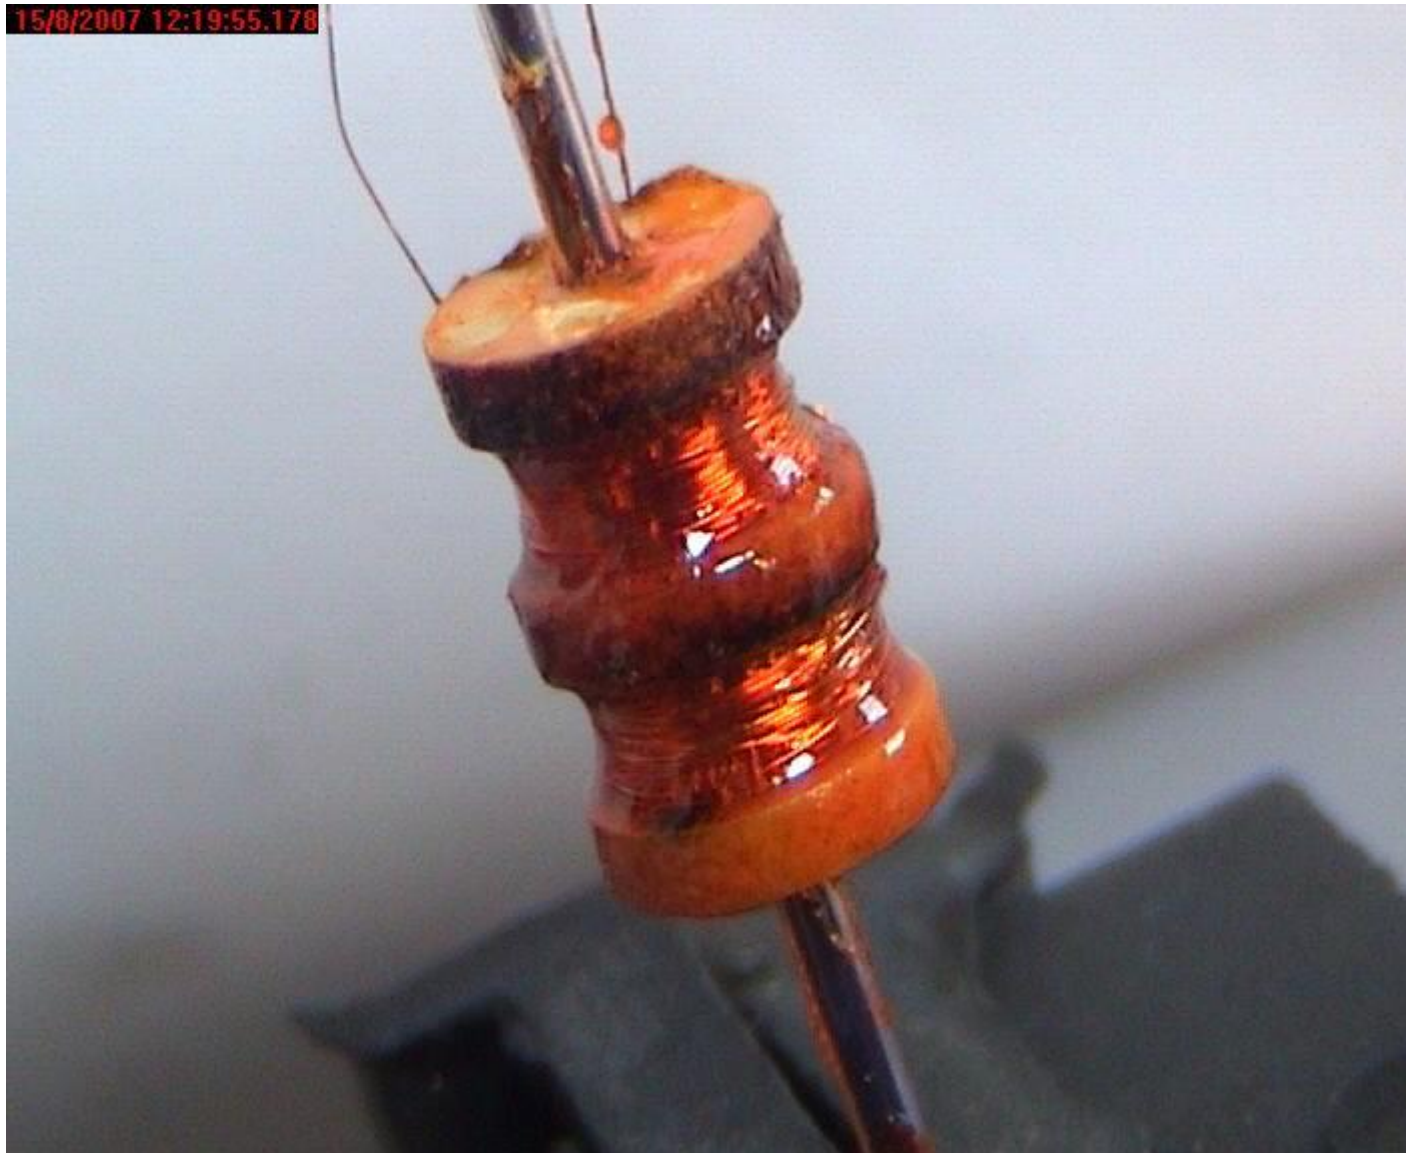
Once the coil is finished it should look like this. Give it a few hours for the varnish to get strong enough to hold it all together. A little warmth will facilitate the process. Interestingly, the varnish dries in two stages. First the solvent evaporates. Then the varnish hardens using oxygen as a catalyst. Of course I was impatient!

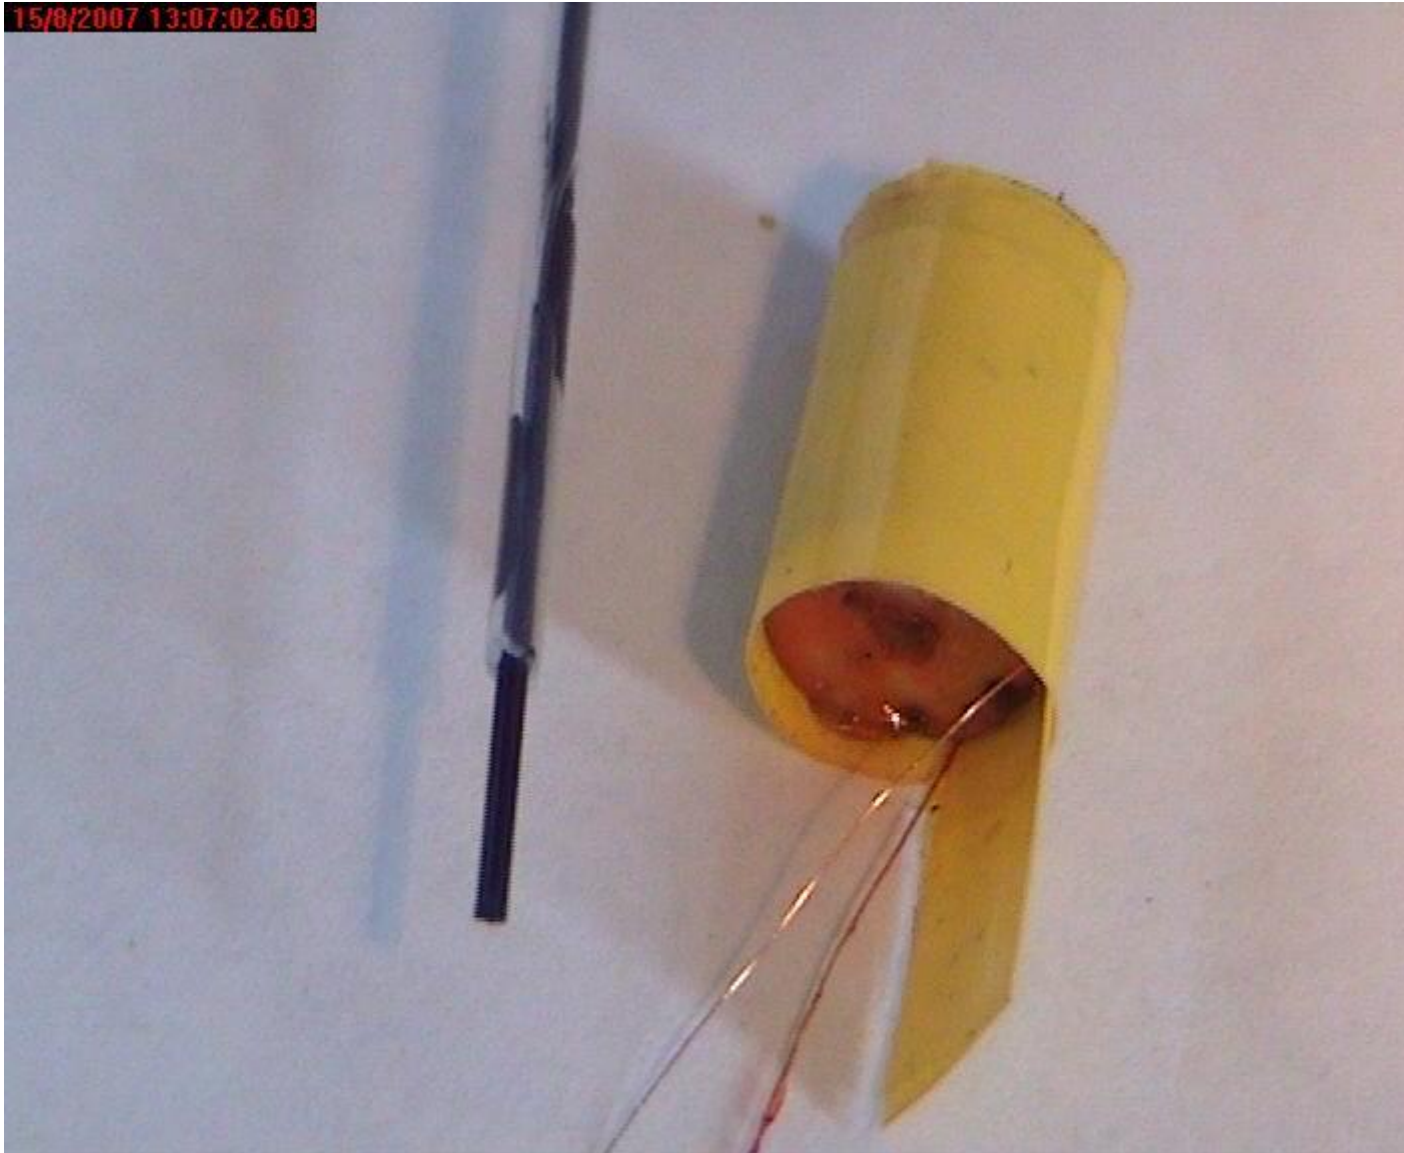
Carefully remove the central steel pin from the mandrel. Then ease the sleeving out of the coil assembly. Tin the wires and measure the resistance. 50 to 60 ohms is good. Infinity is disappointing.

When inserting the coils avoid placing any compressive force on the filter as a whole. I found I was able to insert finger nails into the first gap between the disks so I could push against the copper cup assembly without crushing the coupling rods. If you look closely at the following image you will see the rod on the right has a small bulge. This was damage I inflicted but luckily I was able to pull it straight again
