The R-390A Frequently Asked Questions Page

Repairing Mechanical Filters From An R-390A Graham Baxter G8OAD

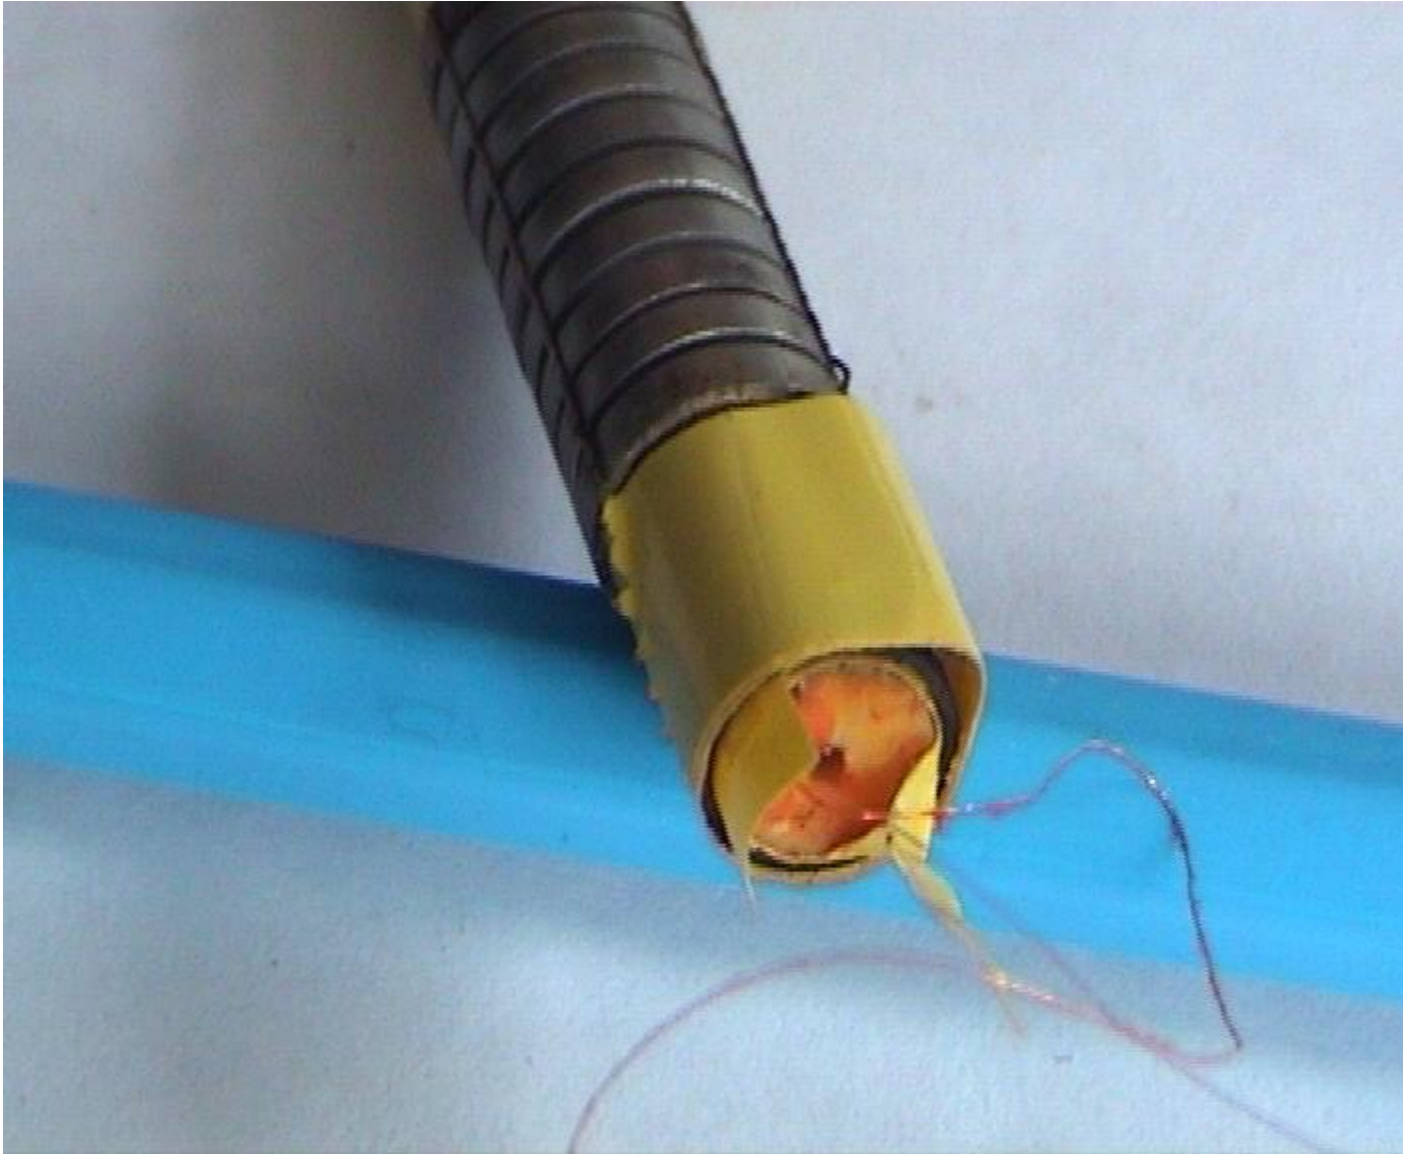
When inserting the coils avoid placing any compressive force on the filter as a whole. I found I was able to insert finger nails into the first gap between the disks so I could push against the copper cup assembly without crushing the coupling rods. If you look closely at the following image you will see the rod on the right has a small bulge. This was damage I inflicted but luckily I was able to pull it straight again

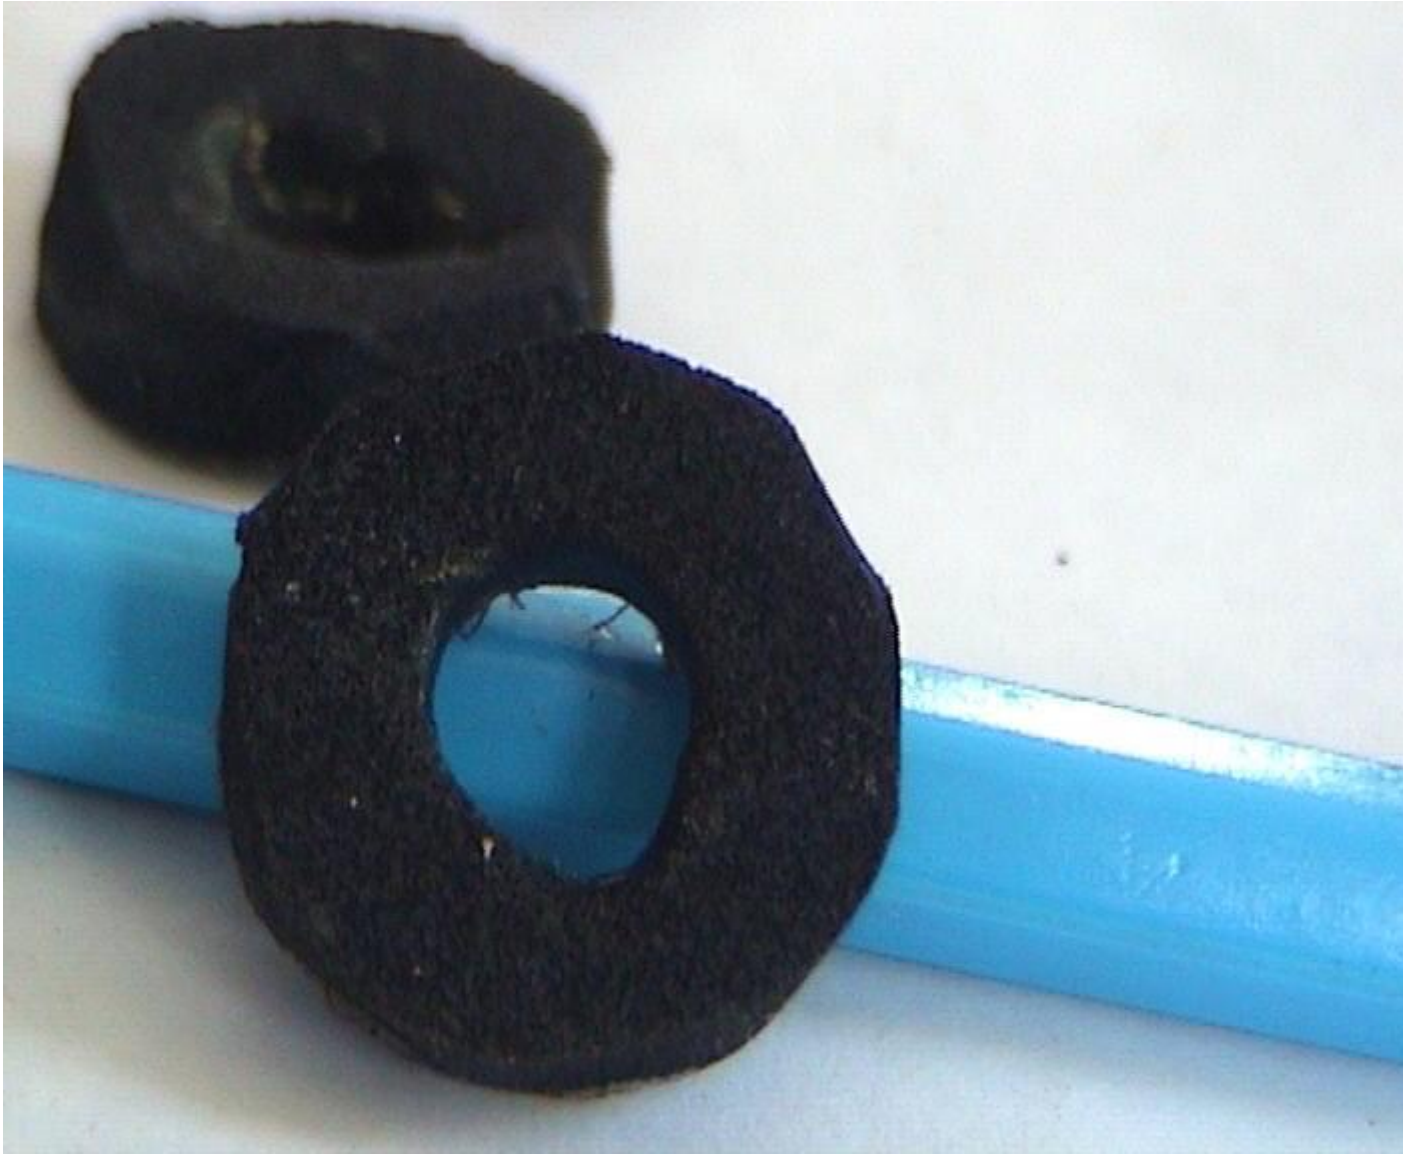
When you are happy with both coils, fifty to sixty ohms, no leakage to the metalwork and the little pin just visible in the centre of the hole, it is time to consider reassembly. You will need to replace the supporting doughnuts. I cut a pair from some air-conditioning pipe self adhesive wrap lagging which I had to hand. A neater job would be to slice doughnuts off ready made tubular lagging. I was attracted by the air-con lagging because presumably it is good with extremes of temperature.

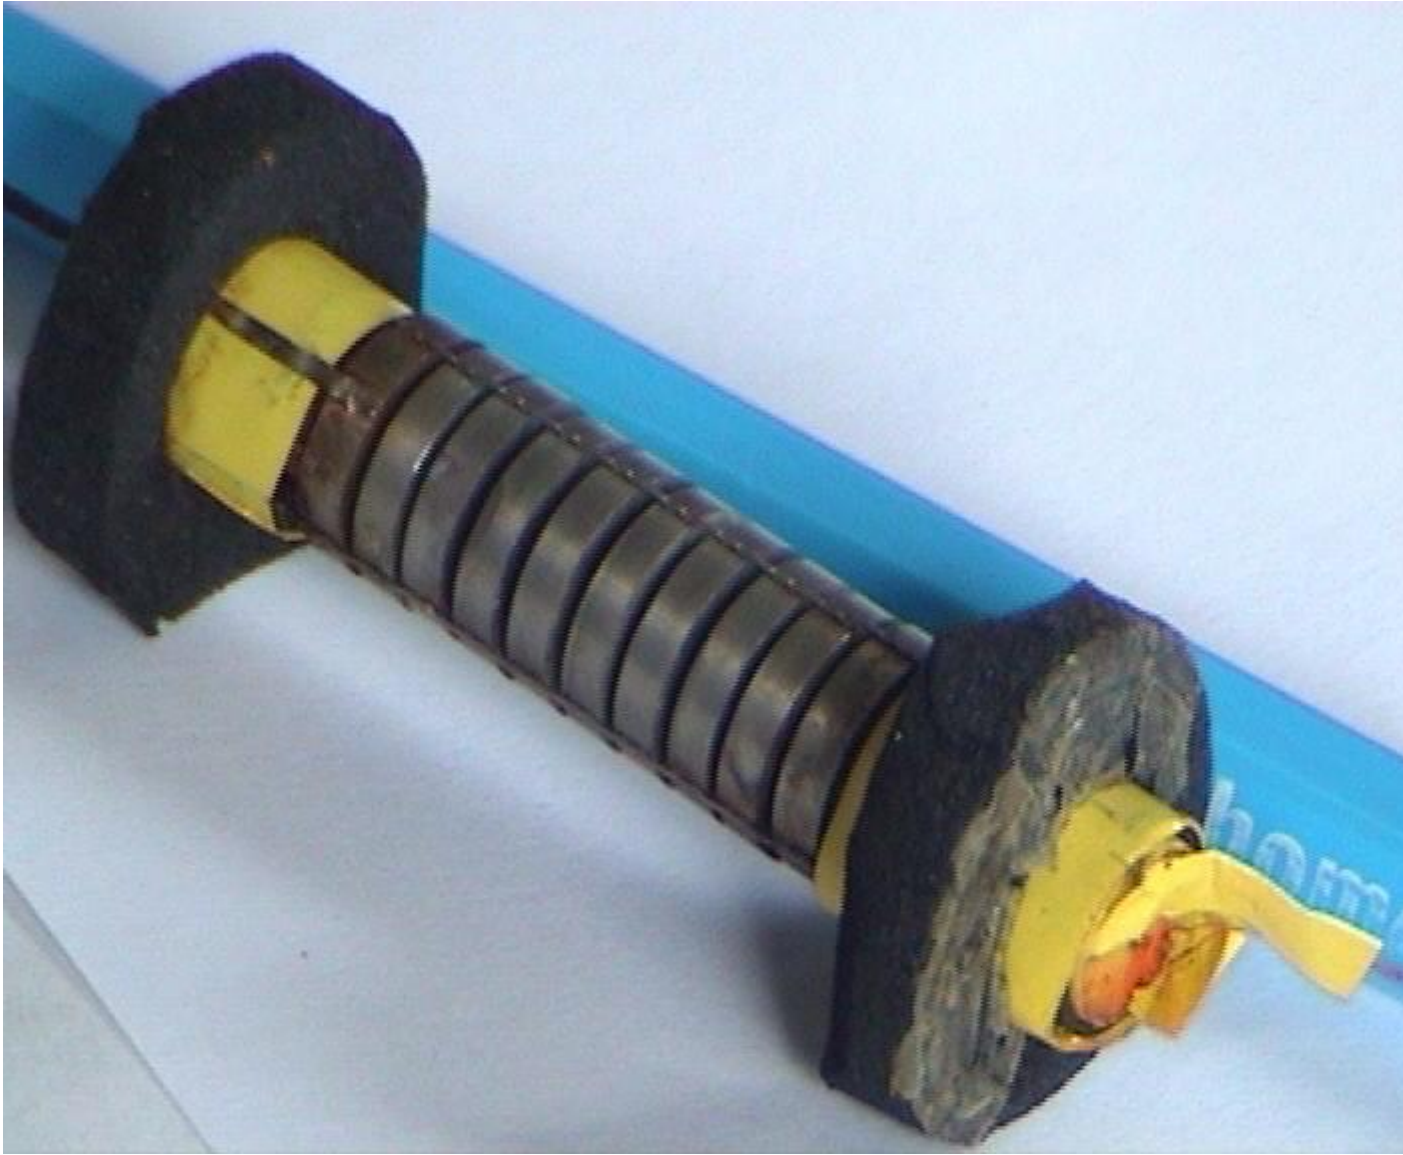
Place a doughnut over each copper cup, taking care not to damage the wires.

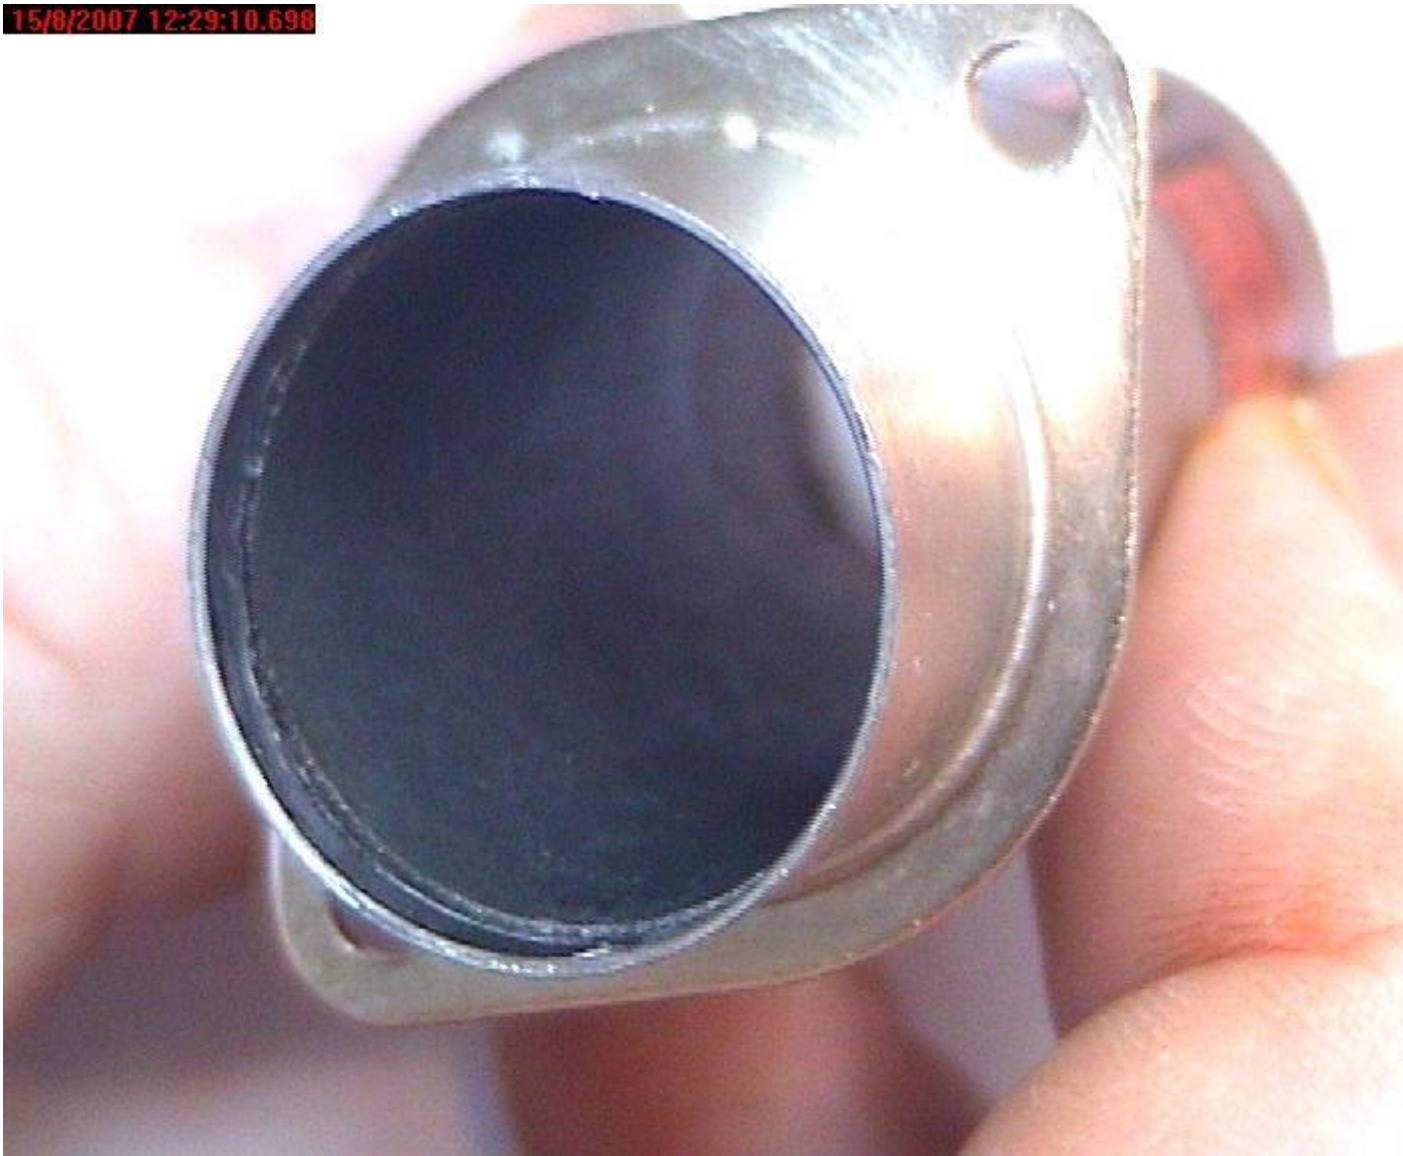
Carefully insert the filter assembly into the barrel. I used the spring hook to manipulate the foam rings as it slid down. The correct position is with the mechanical filter roughly at the longitudinal mid-point of the barrel. The foam rings were placed over the coil cups. I tried to avoid any contact between the foam and the filter disks. If you were able to remove the card tube then you can wrap this round the filter assembly and slide the whole lot back in. Mine was too brittle for re-use.

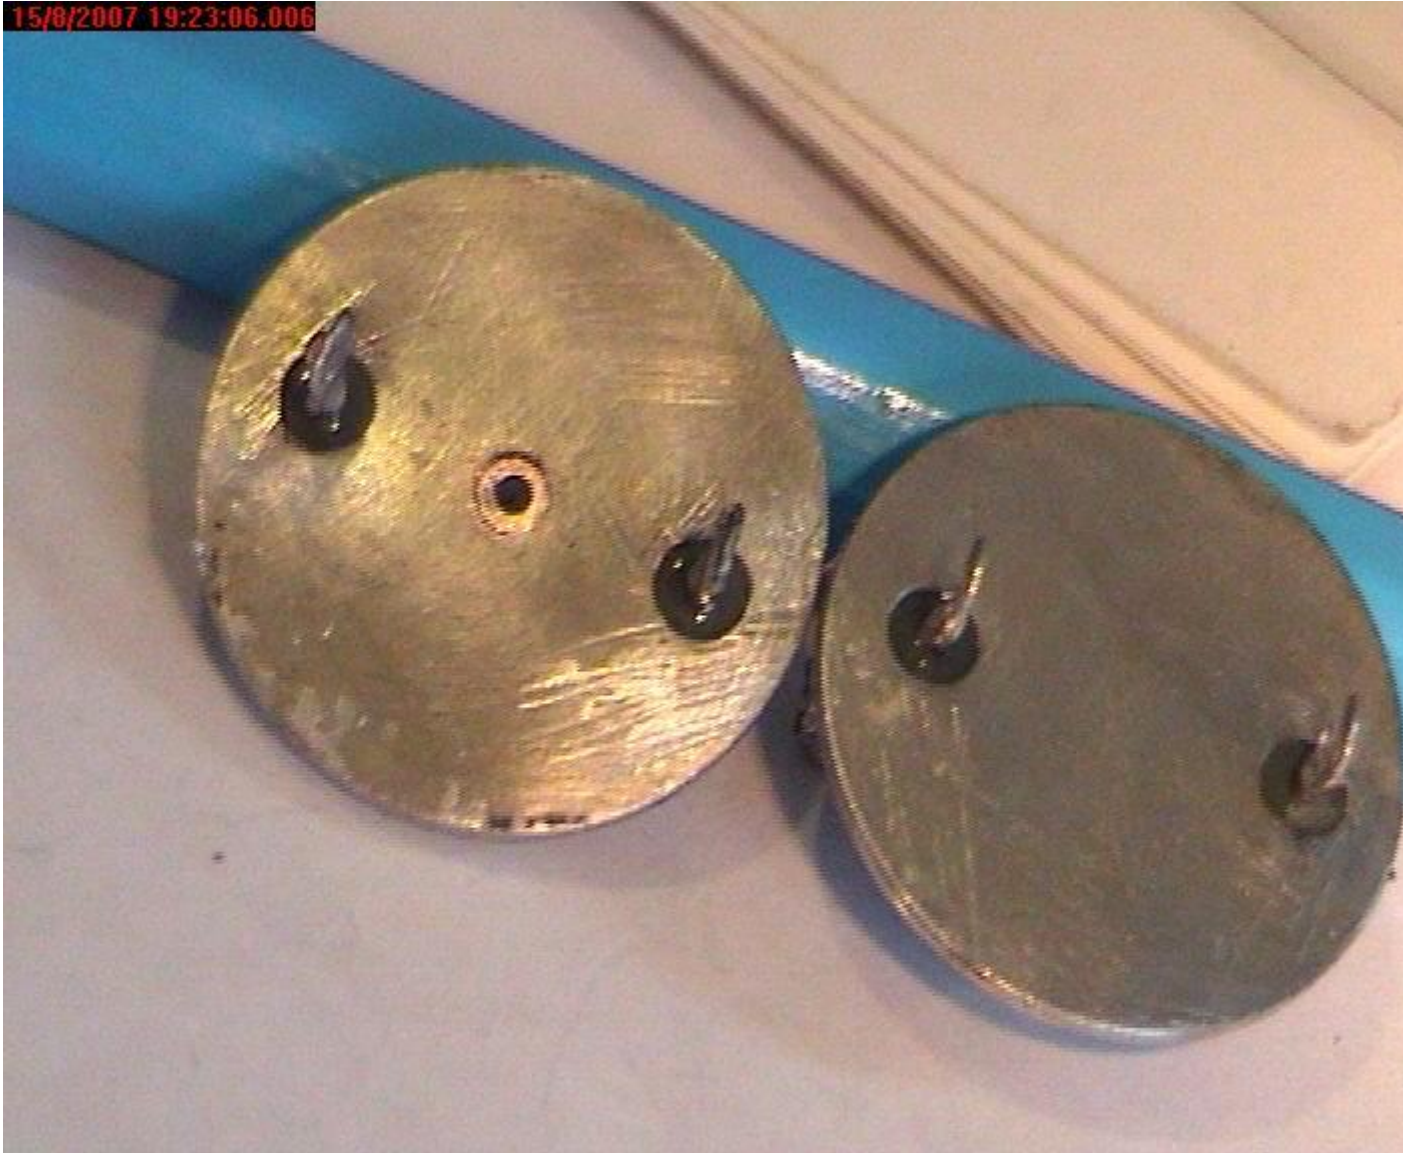
Make sure that the end caps are spotlessly clean, especially around the insulators. I placed a layer of Kapton tape over the internal surface since the original card disks had disintegrated. This was just a precaution to protect the fine wires from heat when re-soldering the case.

Then carefully connect the wires to the tags. Wrap them several times so that they do not disconnect even if the pin is overheated from the outside.

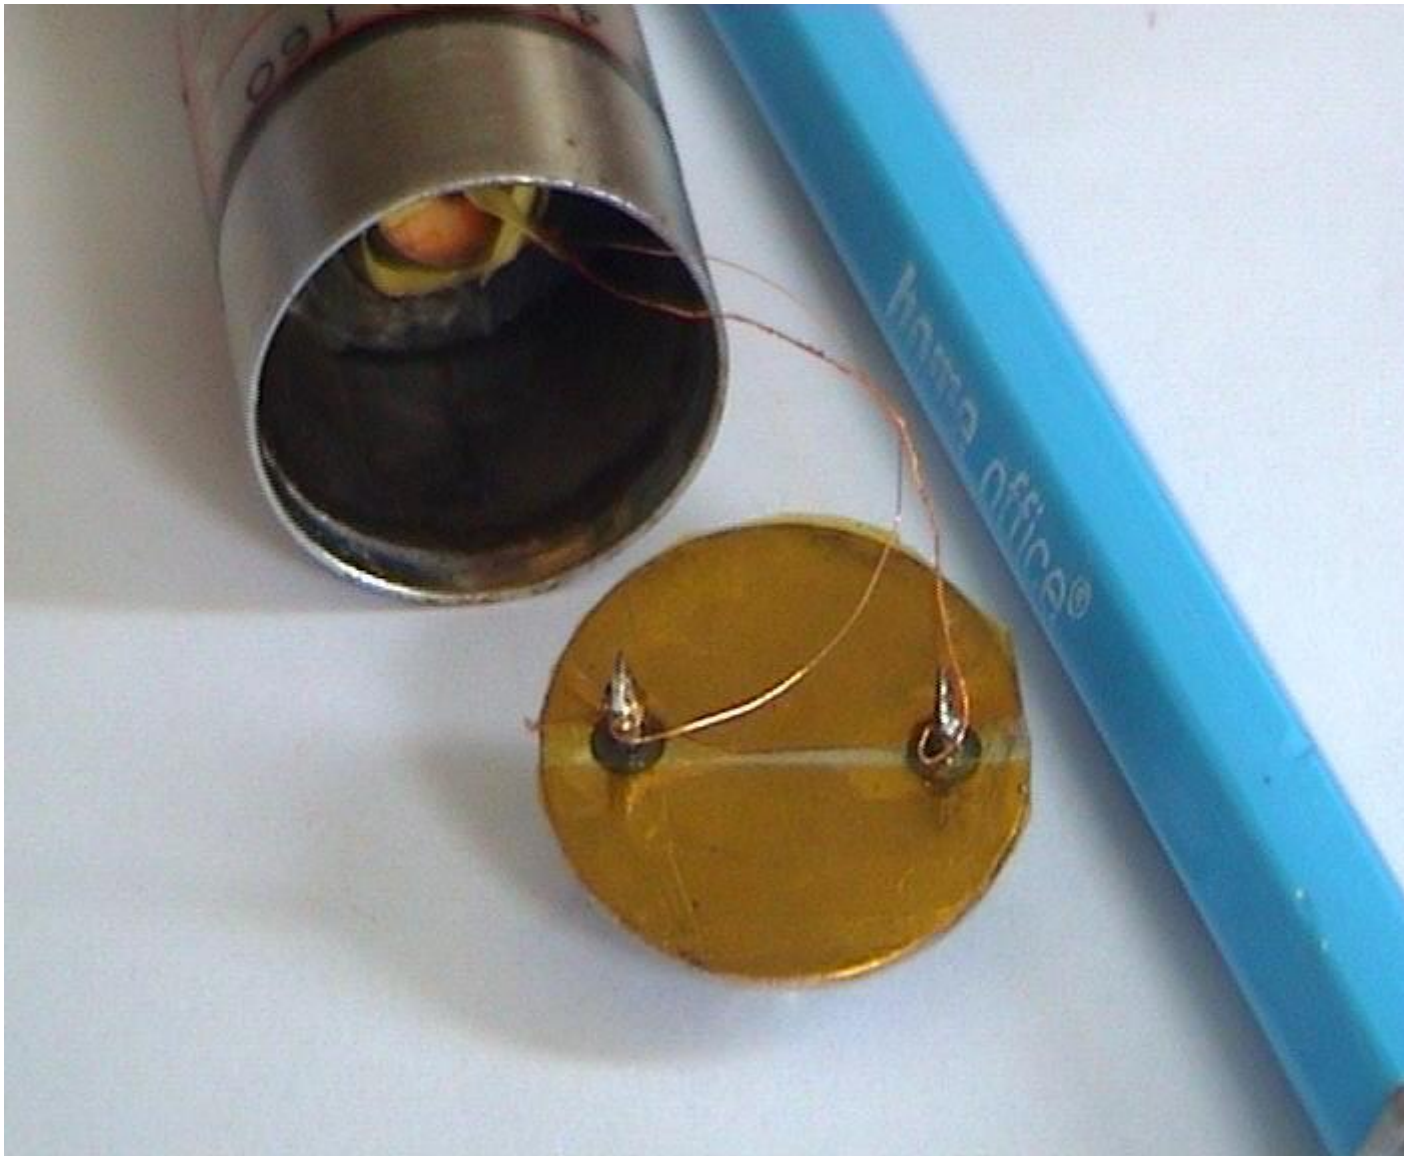
Give it one final test of continuity and leakage before fitting the end caps and re-soldering them. You can do this with a soldering iron if you take your time for it to warm the entire cap. The terminals were in line with the flange mounting holes on my filters. Take care not to trap the wires. I left mine rather long in case any rework was needed. However, no rework was needed and now I am wondering if shorter leads would have improved the ultimate blow-by on account of reduced capacitive coupling.

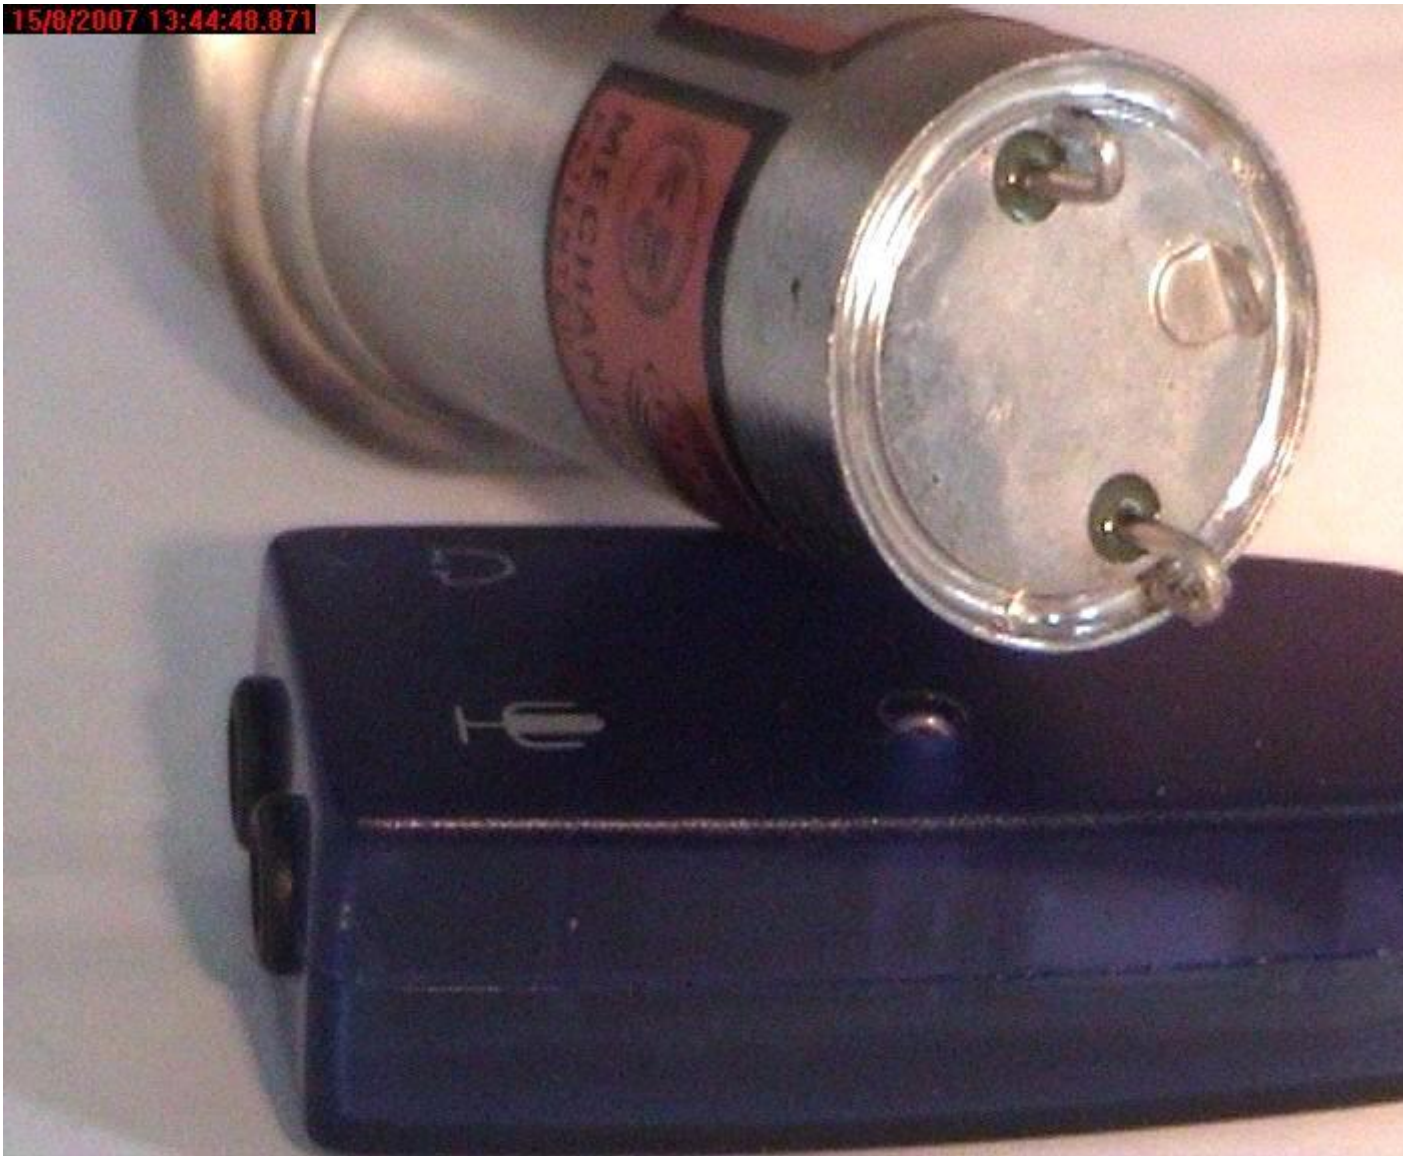
I am quite pleased with the appearance of the resoldered end caps. I think I got lucky!

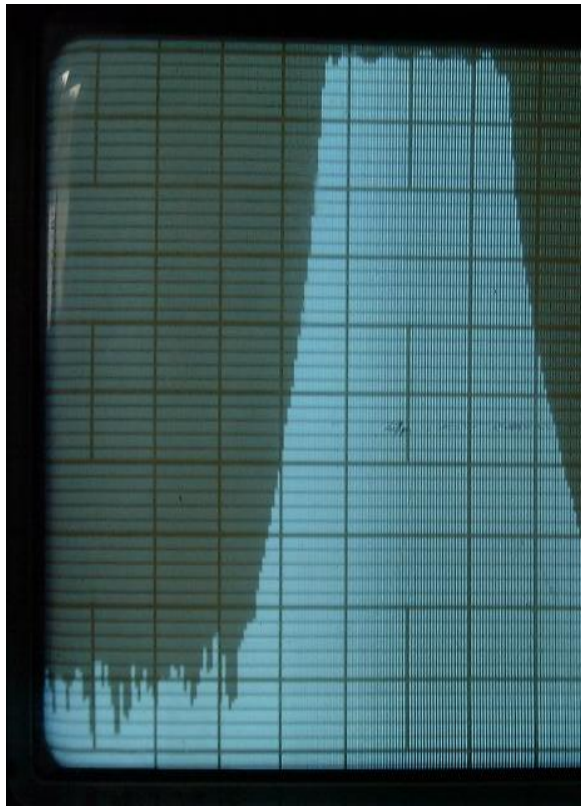
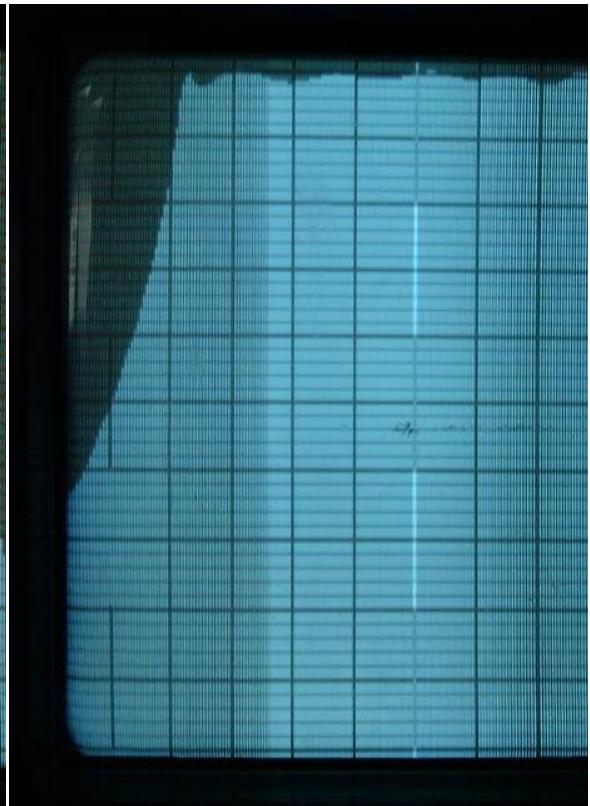
16
k
filt
er

Here are some frequency response plots of the four mechanical filters in the radio. They are all plotted at 10 dB per major vertical division. The 2 kHz filter has not been repaired. It doesn't look right to me!

5 kHz per major horizontal division

2 kHz per major horizontal division

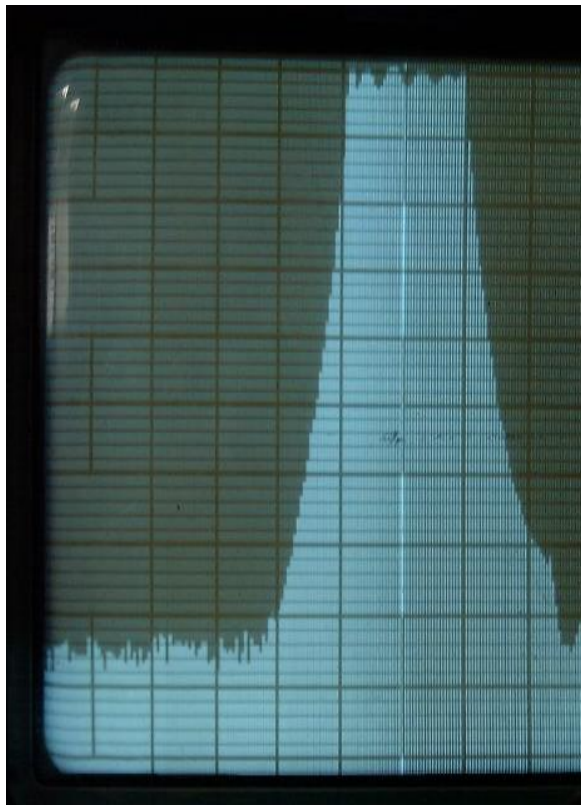
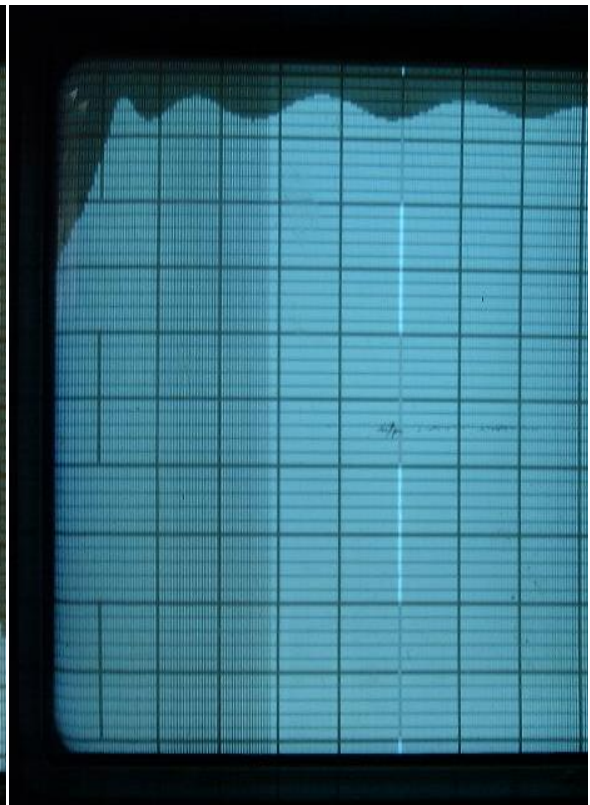
8 k
filt
er

5 kHz per major horizontal division

1 kHz per major horizontal division

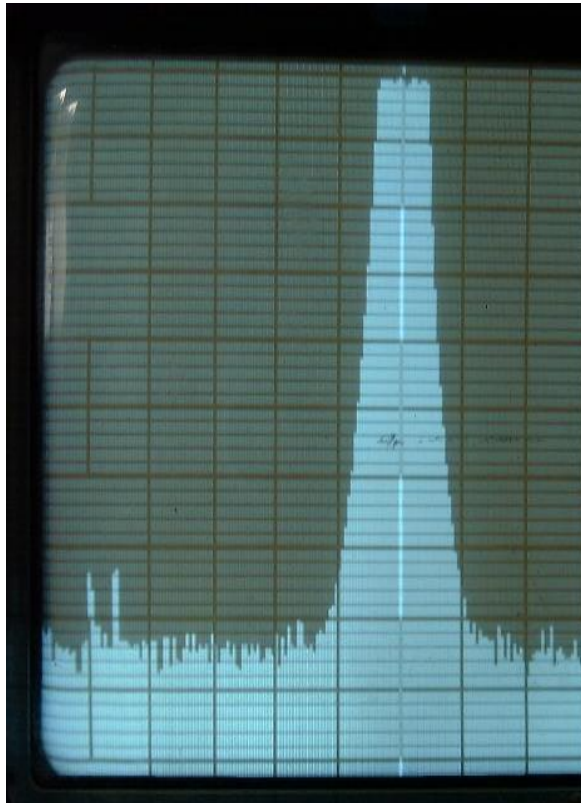
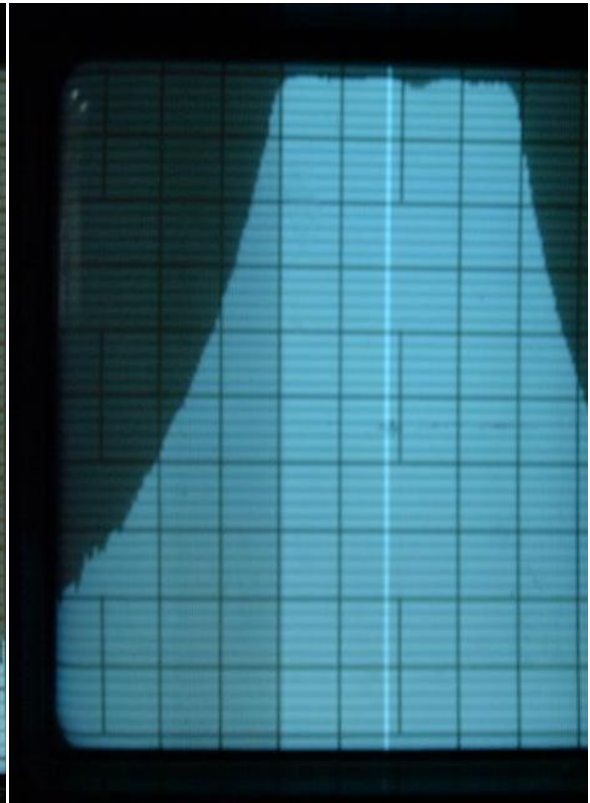
4 k
filt
er

5 kHz per major horizontal division

1 kHz per major horizontal division

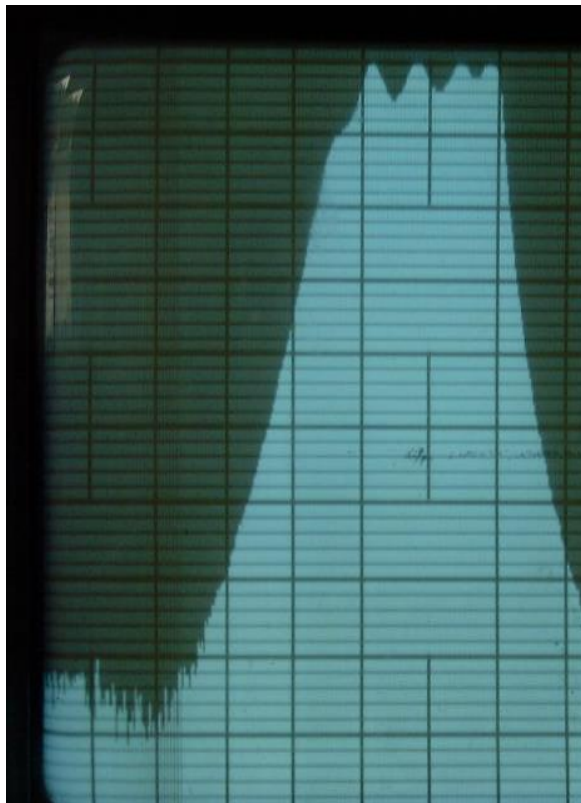
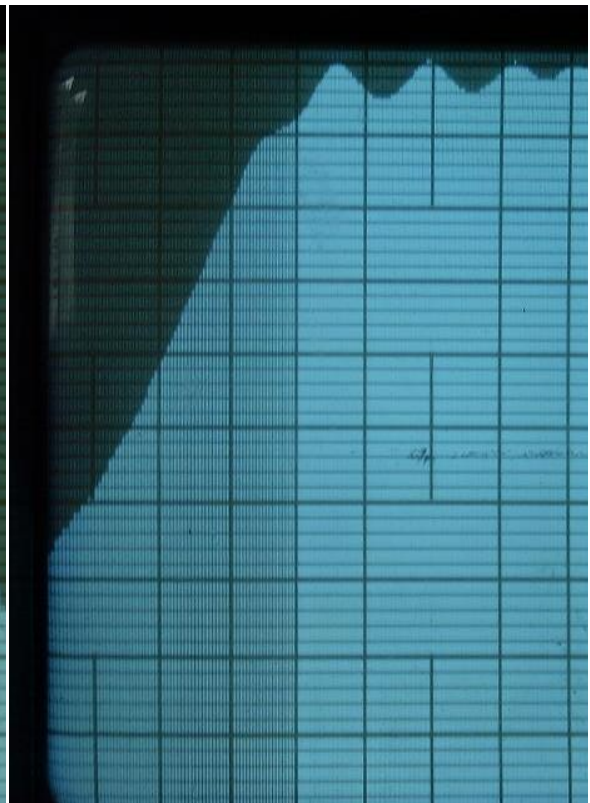
2 k
filt
er

1 kHz per major horizontal division

500 Hz per major horizontal division
